CONFIDENTIAL INSPECTION REPORT

1026 Paseo Rosarito, San Juan Capistrano, CA

10/6/2009 10:00 am to 12:30 pm

SUMMARY REPORT

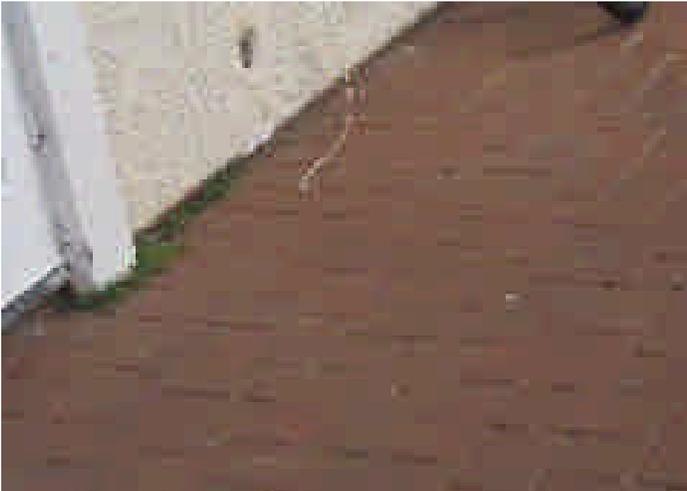
- Portions of the stucco weep-screed flashing have been improperly covered with hardscape. Weep-screed not only allows the house walls to move independent of the foundation and prevents the plate-line cracks or stucco spalling that are commonly seen at the base of many stucco walls but allows any moisture that penetrates the stucco to drain from the stucco walls. It also prevents moisture from wicking up into the stucco from the hardscape\soil area. These conditions can possibly cause moisture penetration into the walls if the vapor barrier is penetrated and possible long term moisture damage or problems. However, the hardscape appeared to slope away from the walls. No evidence was found of moisture intrusion into the inside of the structure in the visible areas along these walls, close monitoring is advised and watching the hardscape during heavy rains to insure proper drainage away from the walls.

Portions of the weep-screed have been covered with hardscape which could result in moisture damage - *Continued*

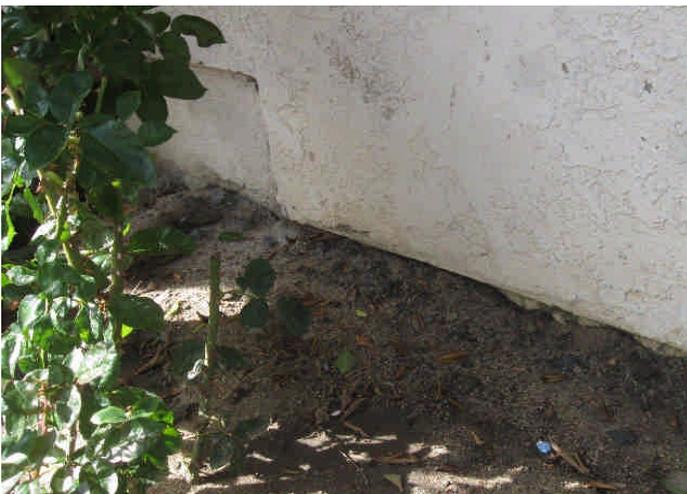
1.1 - → Soil level is too high in some places around the structure and is close or covering the stucco weep screed flashings. Recommend adjusting the soil levels and providing proper drainage in these areas to deliver water away from the foundation and to prevent moisture damage to the stucco and possibly the walls of the structure. No evidence of moisture intrusion found inside these areas at the time of the inspection.

- Soil level is too high in some places around the structure and is close or covering the stucco weep screed flashings. Recommend adjusting the soil levels and providing proper drainage in these areas to deliver water away from the foundation and to prevent moisture damage to the stucco and possibly the walls of the structure. No evidence of moisture intrusion found inside these areas at the time of the inspection.

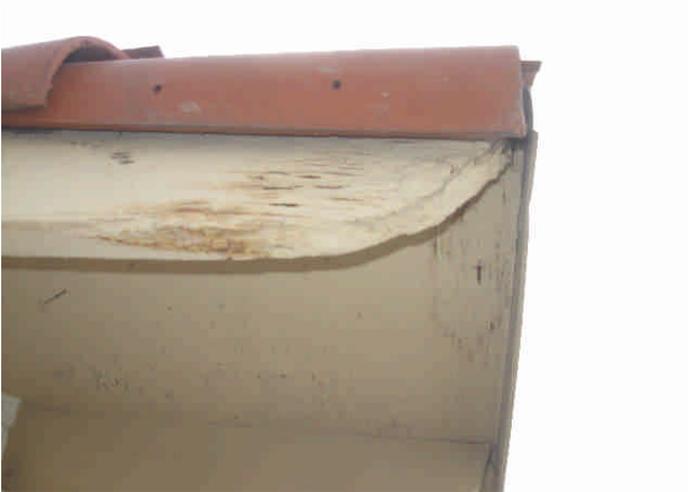
1.2 - → The termite inspector is recommended to further investigate damage to the fascia board, wood trim at the eaves and walls of the structure. Recommend repairs be made to any damaged wood and that any paint peel or bare wood left by wood repairs when any termite work is done be properly painted.

- The termite inspector is recommended to further investigate damage to the fascia board, wood trim at the eaves and walls of the structure. Recommend repairs be made to any damaged wood and that any paint peel or bare wood left by wood repairs when any termite work is done be properly painted.

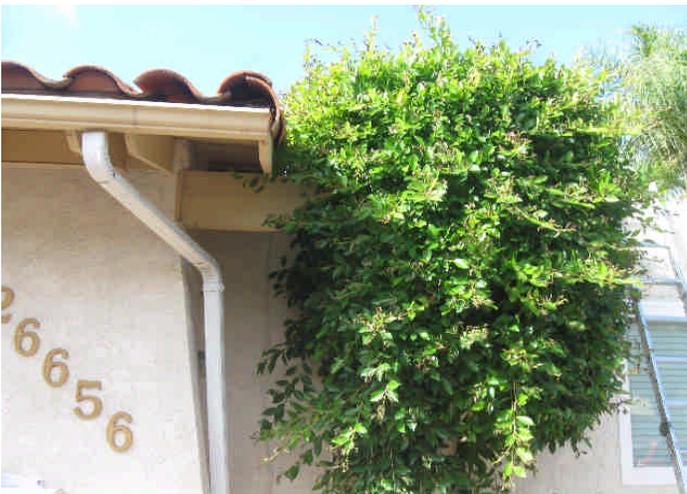
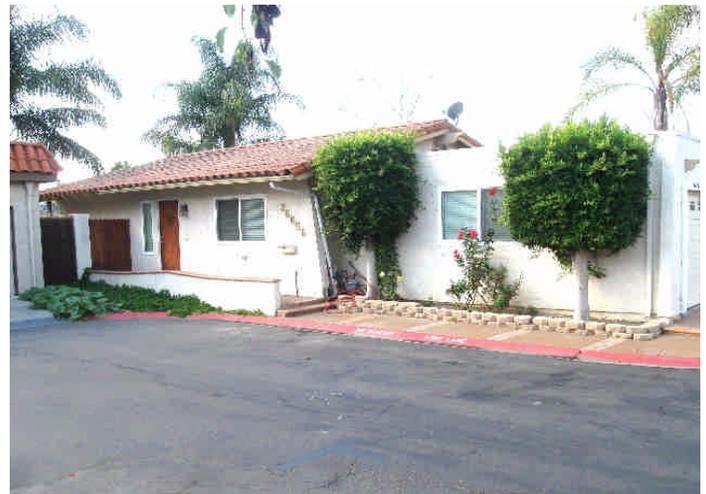
- 1.7 - → Trees next to the hardscape or walls of the structure should be monitored, kept pruned or removed to protect from damage to the structure or the hardscape, tree branches should be kept a minimum of 12" away from the structure.

- Trees next to the hardscape or walls of the structure should be monitored, kept pruned or removed to protect from damage to the structure or the hardscape, tree branches should be kept a minimum of 12" away from the structure.

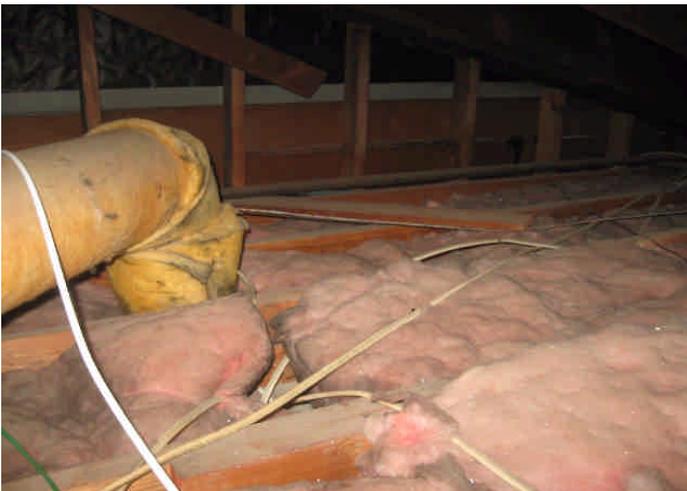
- The attic floor is insulated with approximately 6-inches of fiberglass, batt insulation. Current new construction standards call for nine and even twelve-inches.

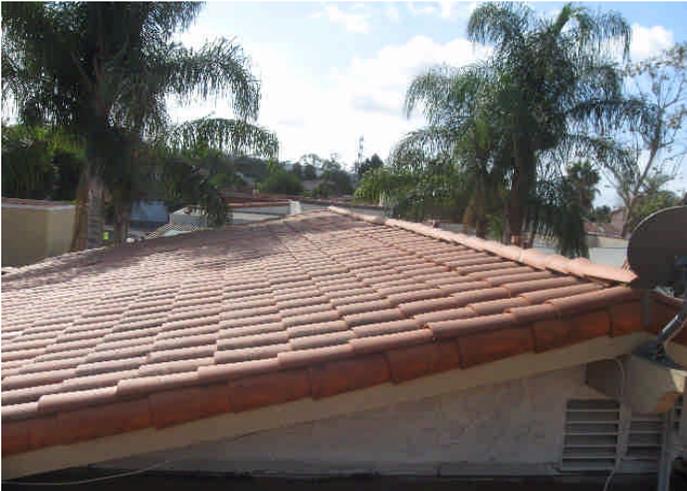
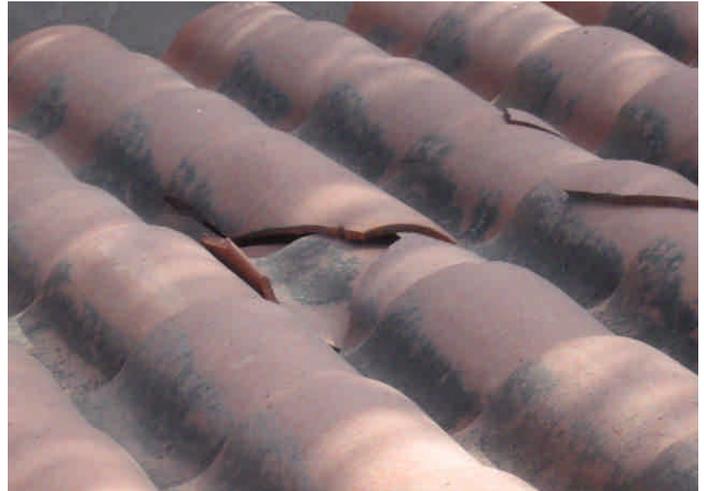
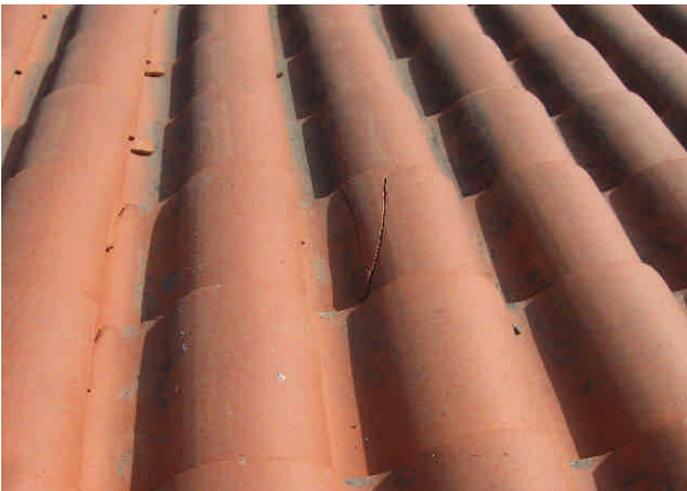
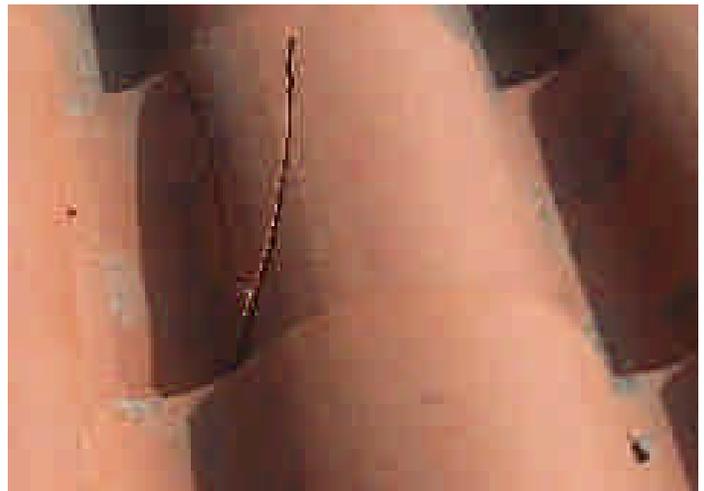
- 3.2 - → The clay tile roof appears to be the same age as the home and is around 30 years old without any evidence of leaking found at the ceilings or attic. To avoid damaging the tiles, we elected not to walk on the roof, and inspected it instead from within the attic and from the adjoining roof. There are some cracked, broken and displaced clay tiles that are recommended to be repaired/replaced. Recommend servicing by a roofing specialist before close of escrow.

- The clay tile roof appears to be the same age as the home and is around 30 years old without any evidence of leaking found at the ceilings or attic. To avoid damaging the tiles, we elected not to walk on the roof, and inspected it instead from within the attic and from the adjoining roof. There are some cracked, broken and displaced clay tiles that are recommended to be repaired\replaced. Recommend servicing by a roofing specialist before close of escrow.

The clay tile roof appears to be the same age as the home - *Continued*

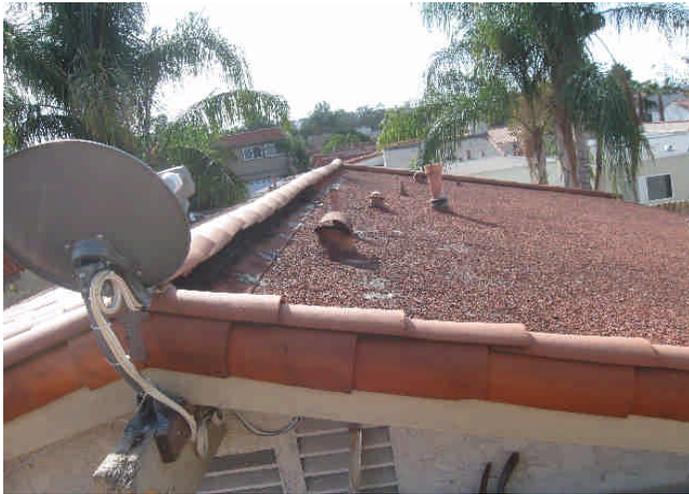
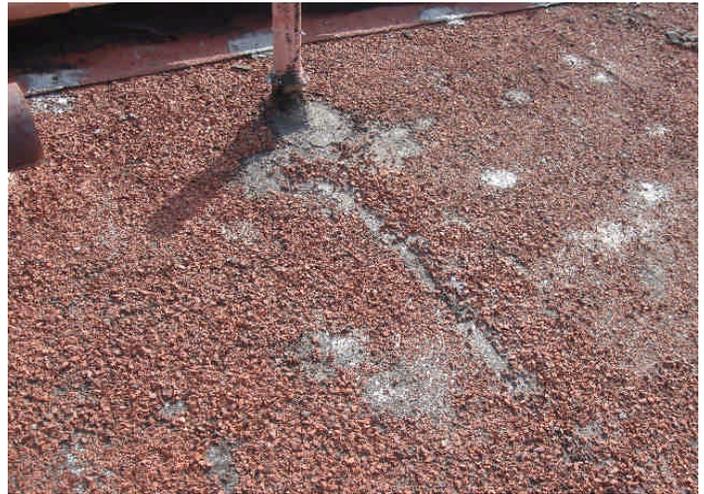
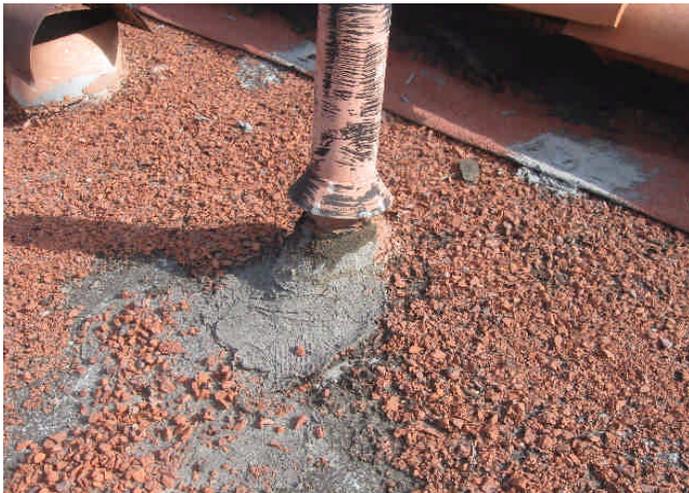
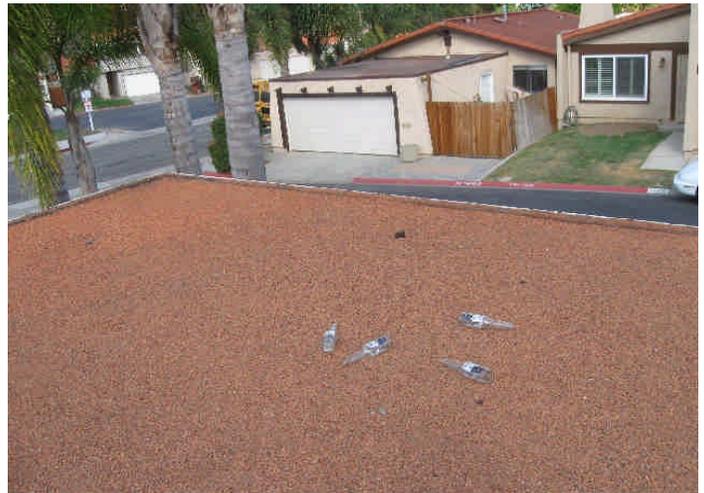
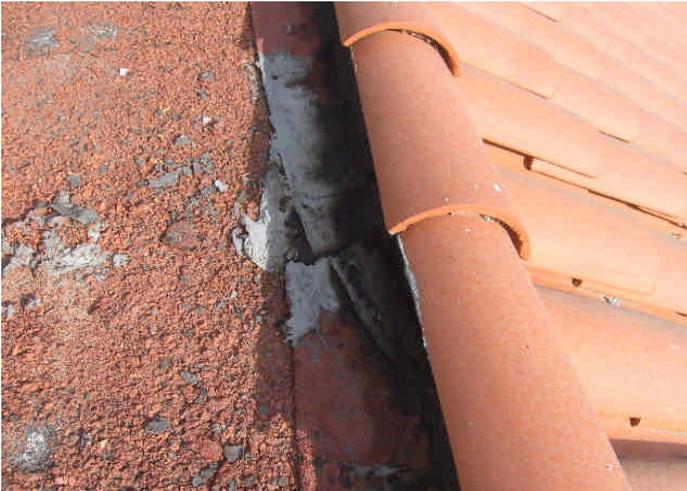
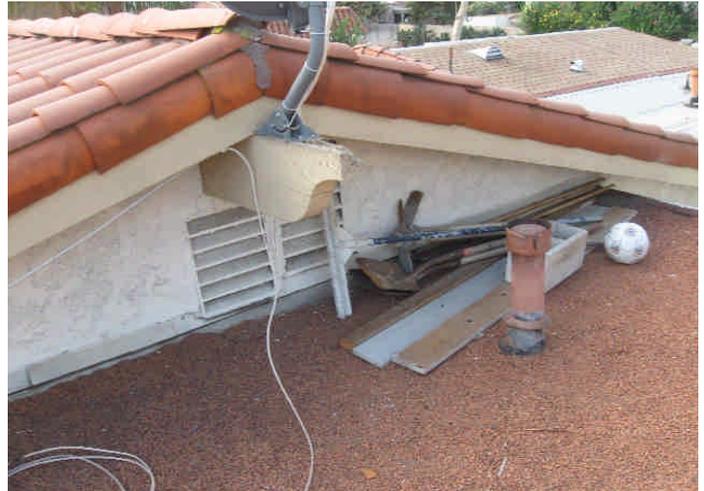
- 3.3 - → The hot mop\tar gravel coated roof is an older roof that is starting to show signs of wear. There are cracks in the tar \under coating and bare spots without gravel that need to be sealed and covered, and it will need to be serviced to extend the life of the roof system. No evidence of leaking was found in the structure, however, we have not had recent rains. The gravel type roof is approaching the end of its design life and is recommended to be further evaluated by a roofing specialist for cost of repairs or replacement before close of escrow.

- The hot mop\tar gravel coated roof is an older roof that is starting to show signs of wear. There are cracks in the tar \under coating and bare spots without gravel that need to be sealed and covered, and it will need to be serviced to extend the life of the roof system. No evidence of leaking was found in the structure, however, we have not had recent rains. The gravel type roof is approaching the end of its design life and is recommended to be further evaluated by a roofing specialist for cost of repairs or replacement before close of escrow.

The gravel roof is older and starting to show signs of wear - *Continued*

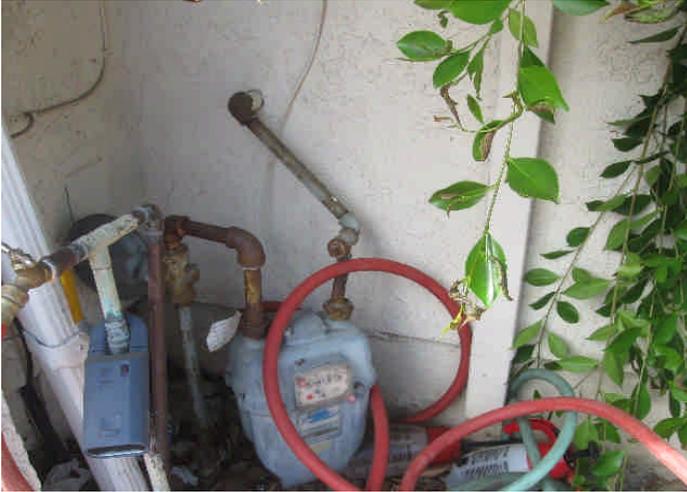
- 5.1 - ↪ Recommend the gas shut off valve have a wrench located at the shut off valve or a seismic auto shut off valve installed in case of emergency. Some insurance companies are now requiring that an automatic gas shut off gas valve be installed before they will insure you, this should be verified with your insurance company. They cost around \$350 to install. Some City construction jurisdictions require the auto shut off valves when a property is sold, verify with your City or insurance company on requirements before close of escrow. If the wrench only is used, it is recommended that the Gas Company's gas meter valve be verified as easily operated.

- Recommend the gas shut off valve have a wrench located at the shut off valve or a seismic auto shut off valve installed in case of emergency. Some insurance companies are now requiring that an automatic gas shut off gas valve be installed before they will insure you, this should be verified with your insurance company. They cost around \$350 to install. Some City construction jurisdictions require the auto shut off valves when a property is sold, verify with your City or insurance company on requirements before close of escrow. If the wrench only is used, it is recommended that the Gas Company's gas meter valve be verified as easily operated.

Recommend the gas shut off valve have a wrench attached or a seismic auto shut off valve installed - *Continued*

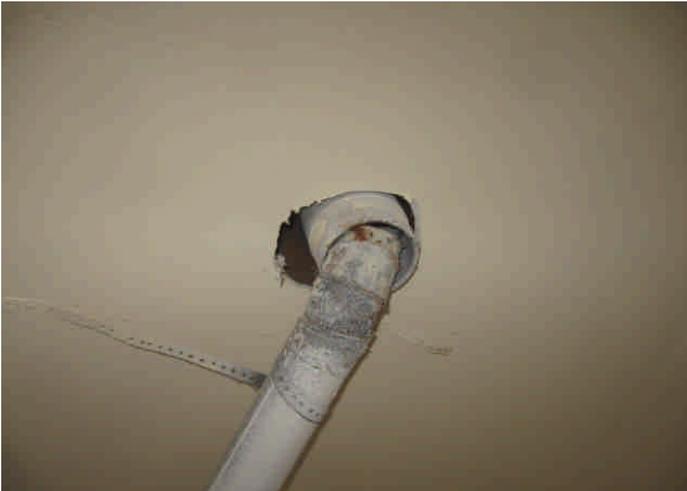
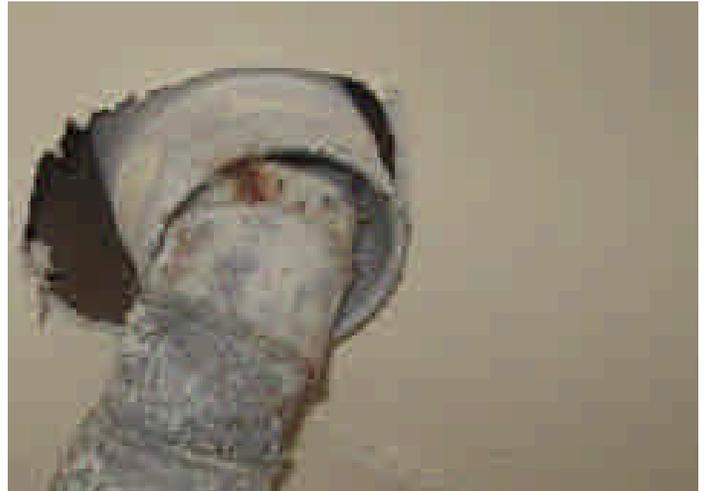
- 5.4 - ✓ **Gas water heater vent pipe is not screw-strap anchored and not properly installed, single wall vent pipe should have three screws installed at each joint and at the bell diverter housing at the top of the water heater with securing the bell housing to the top of the water heater to prevent movement, the transition housing at the ceiling should be strap or screw anchored to prevent movement and possible exhaust fumes from escaping, recommend further evaluation and corrections. (vent pipe was not properly seated into the ceiling vent pipe allowing some exhaust gases into the garage)**

- ✓ **Gas water heater vent pipe is not screw-strap anchored and not properly installed, single wall vent pipe should have three screws installed at each joint and at the bell diverter housing at the top of the water heater with securing the bell housing to the top of the water heater to prevent movement, the transition housing at the ceiling should be strap or screw anchored to prevent movement and possible exhaust fumes from escaping, recommend further evaluation and corrections. (vent pipe was not properly seated into the ceiling vent pipe allowing some exhaust gases into the garage)**

Gas water heater vent pipe is not screw-strap anchored and not properly installed - *Continued*

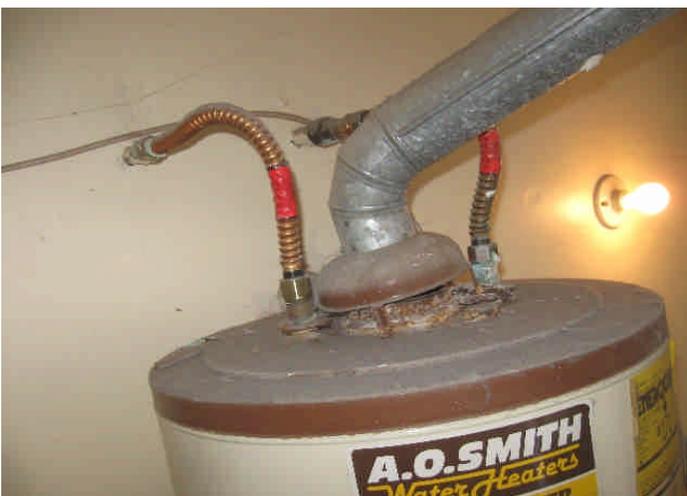
- The pipe nipple to flex water supply pipe at the water connectors at the top of the water heater are corroded and are recommended to be monitored, no current leaking found.

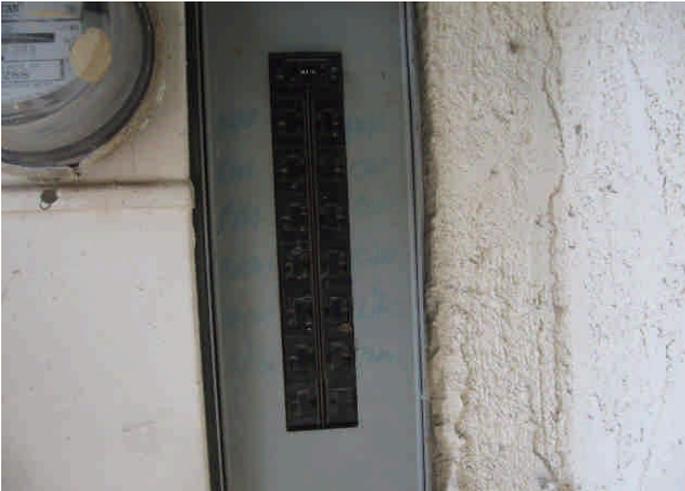
- Various circuits within the main panel are not all labeled and are recommended to be, so that the appropriate load calculations and breaker uses could be determined.

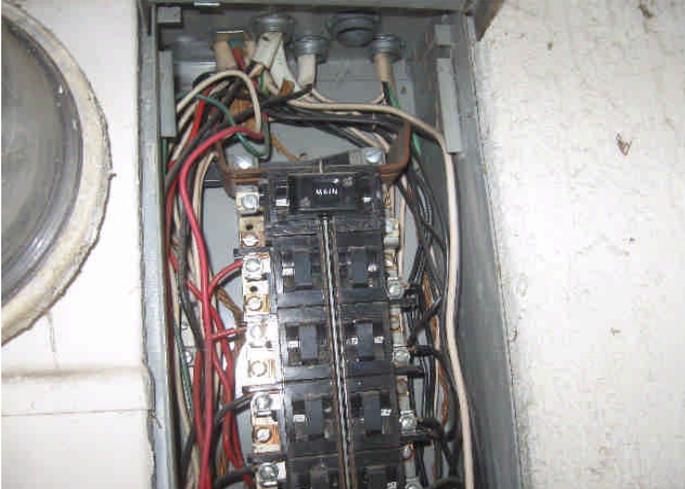
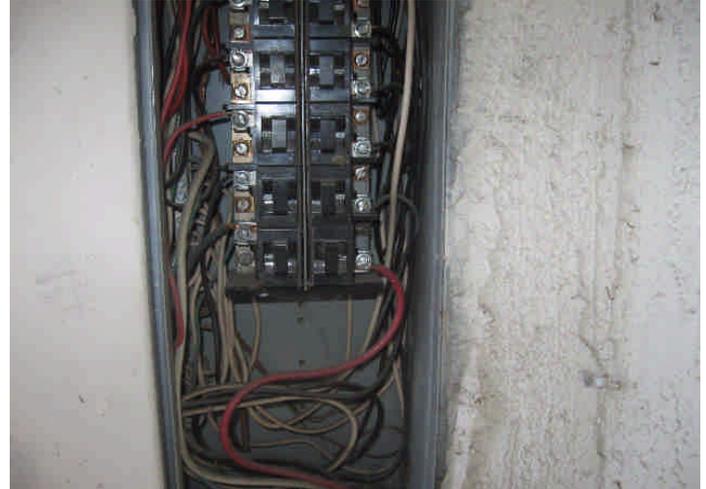
- 6.1 - ↪ The main electric panel is an older electrical panel-breaker system. Breakers as they get older may not perform properly when they should trip and the panel with age develops corrosion and rust that may not be evident. Recommend that the older panel be checked by an electrical specialist for possible corrections or upgrades.
- 6.2 - ↪ The main electric panel and breakers are an older push type breaker system that are known to be problematic and are difficult to find replacement breakers, are difficult to reset and sometimes indicate that a breaker has reset when tripped and is still not furnishing power, recommend each breaker be tested and verified as functional by an electrical specialist.

- The main panel employs Push-matic, that are an older breaker system that have a history of sticking or are difficult to reset. Recommend that each circuit breaker be tested and verified as functional. However, no evidence of broken/damaged breakers or burnt wires were found in the panel at the time of the inspection.

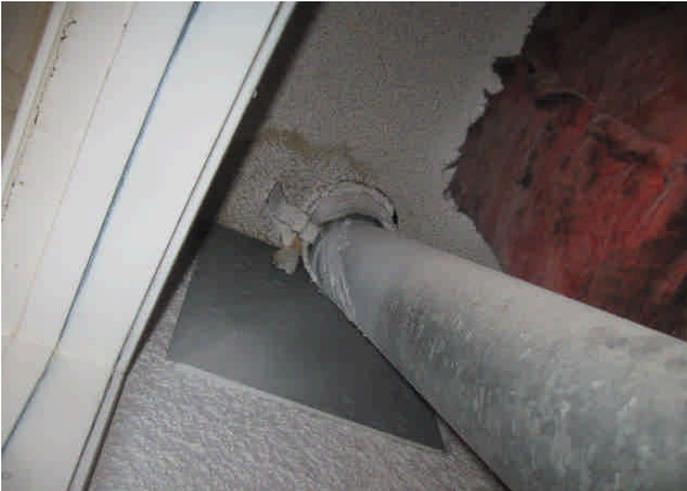
7.2 - r Transite\cement vent pipe on the furnace is a known asbestos-containing material, recommend upgrading to a currently approved double wall\B-vent metal pipe and having the Transite vent pipe properly removed and disposed of by a qualified specialist.

- Transite\cement vent pipe on the furnace is a known asbestos-containing material, recommend upgrading to a currently approved double wall\B-vent metal pipe and having the Transite vent pipe properly removed and disposed of by a qualified specialist.

The vent pipe is installed with transite a known asbestos-containing material - *Continued*

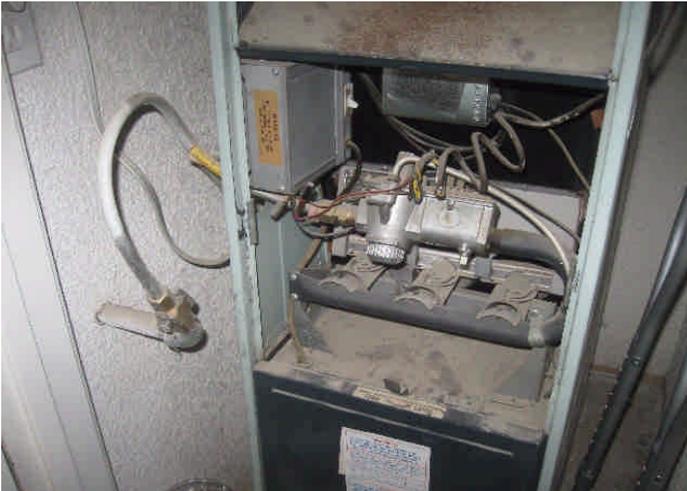
7.4 - r The natural gas flex line improperly extends through the wall of the furnace to inside gas valve assembly, it is recommended that an approved stainless flex line be installed to a rigid steel gas line extending from inside the furnace to the exterior. This is to prevent possible vibration\rub or seismic damage to the thin walls of the gas flex line.

- The natural gas flex line improperly extends through the wall of the furnace to inside gas valve assembly, it is recommended that an approved stainless flex line be installed to a rigid steel gas line extending from inside the furnace to the exterior. This is to prevent possible vibration\rub or seismic damage to the thin walls of the gas flex line.

The natural gas flex line improperly extends through the wall of the furnace to inside gas valve assembly - *Continued*

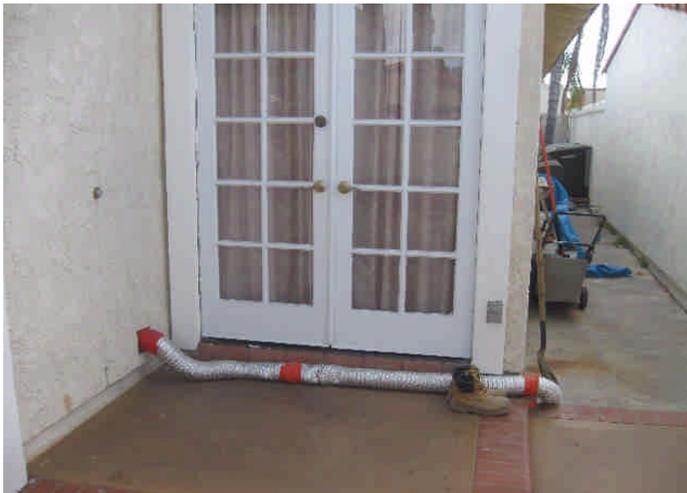
15.1 - → The dryer vent is in place and vents to the exterior, however, the exterior wall back draft cap has been removed and a flex pipe extended under a door and walking surface, recommend removing the trip hazard and re-installing the wall mounted back draft cap.

- The dryer vent is in place and vents to the exterior, however, the exterior wall back draft cap has been removed and a flex pipe extended under a door and walking surface, recommend removing the trip hazard and re-installing the wall mounted back draft cap.

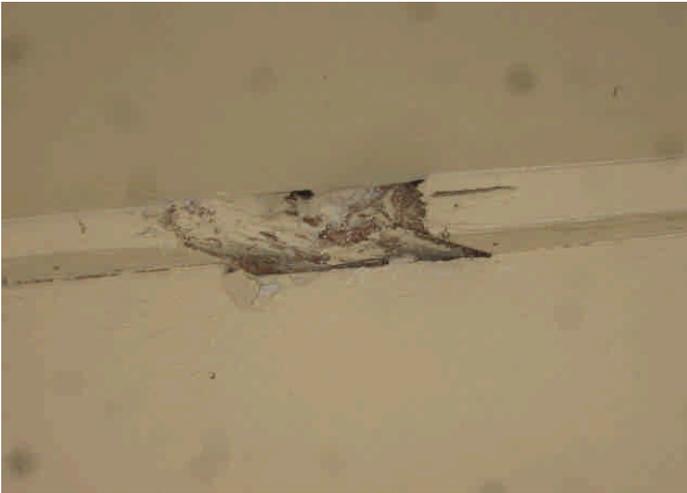
16.2 - → There is evidence of damage wood from wood destroying pests, refer to the termite inspector for further evaluation and corrections.(small section of wood at the wall to ceiling location)

- There is evidence of damage wood from wood destroying pests, refer to the termite inspector for further evaluation and corrections.(small section of wood at the wall to ceiling location)

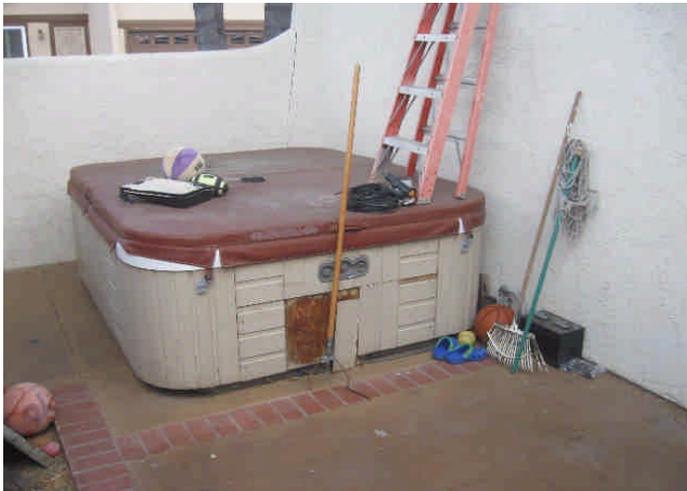
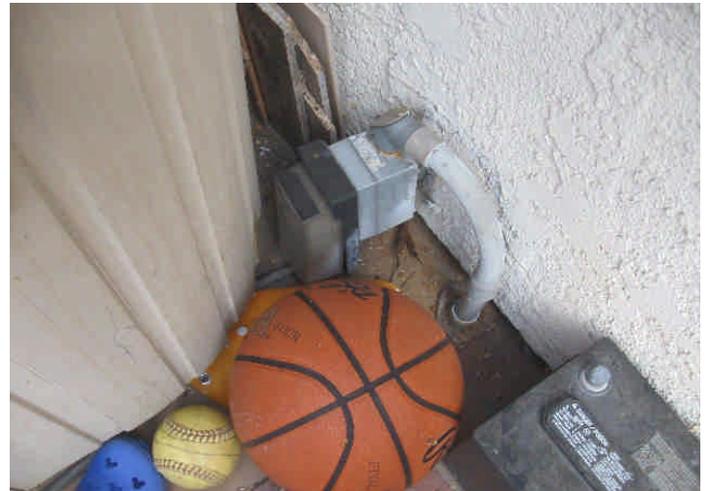
- ✓ **The portable spa was not evaluated and was reported to not stay with the property, recommend insuring the electrical connections are properly secured and covered when the spa is removed.**
