## CONFIDENTIAL INSPECTION REPORT

### Older Home Example

511 Broadway, Whittier, CA

12/12/2009 2:30 pm to 5:00 pm

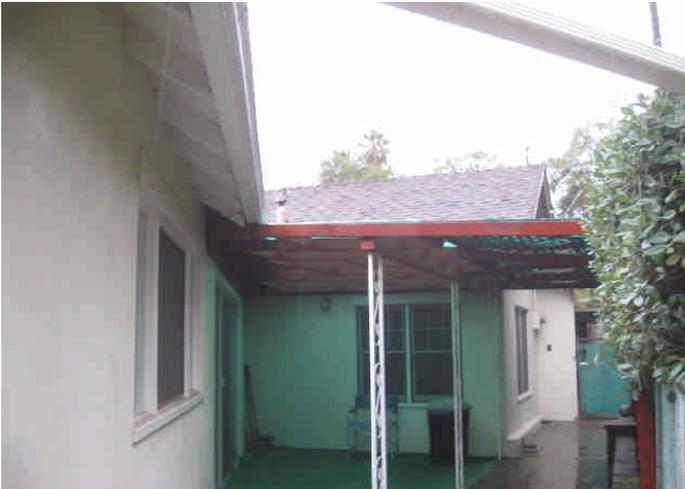
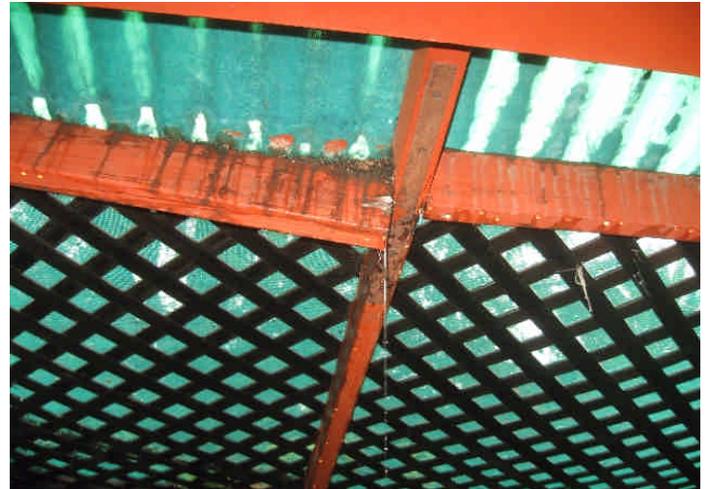
- There is moisture stains/wood damage to the patio wood shade cover members that are recommended to be evaluated by the termite inspector and repairs made.

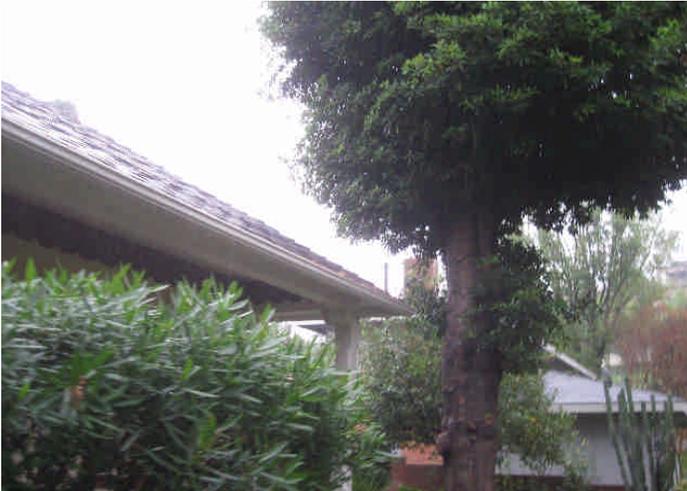
- Vegetation is encroaching on the structure, and should be kept a minimum of twelve inches away for the general welfare of the walls, roof and foundation.
- There are tree limbs overgrowing or against the walls the structure that are recommended be trimmed and monitored, to insure that they do not impact or damage the roof/walls or their components.

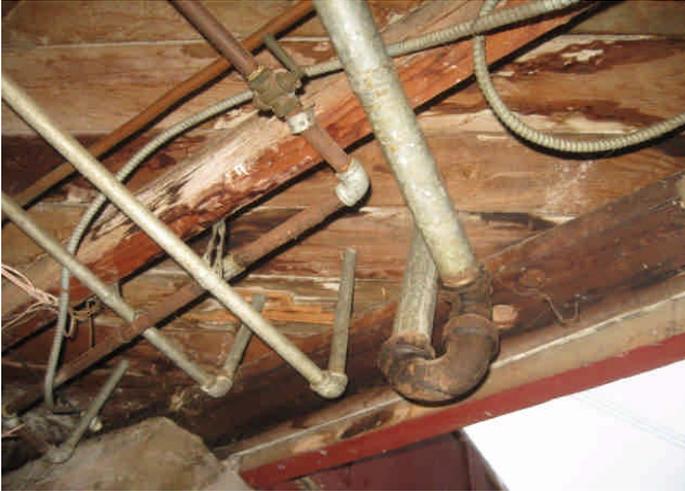
- Moisture stains noted under bathroom-kitchen areas, recommend further evaluation by the termite inspector.

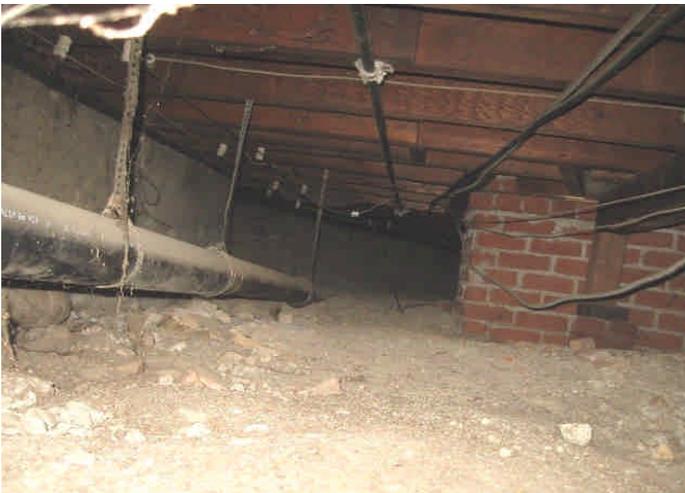
- There is no floor insulation, which may not have been required when this residence was constructed. Recommend upgrading.

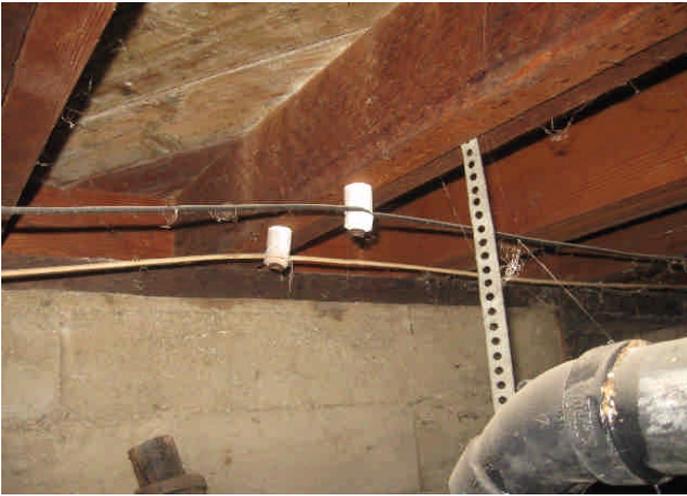
- Obsolete and suspect knob and tube wiring is present within the crawlspace, which should be inspected and certified as safe, or replaced by a licensed electrician.

Obsolete knob-and-tube wiring is present within the crawlspace and should be further evaluated - *Continued*

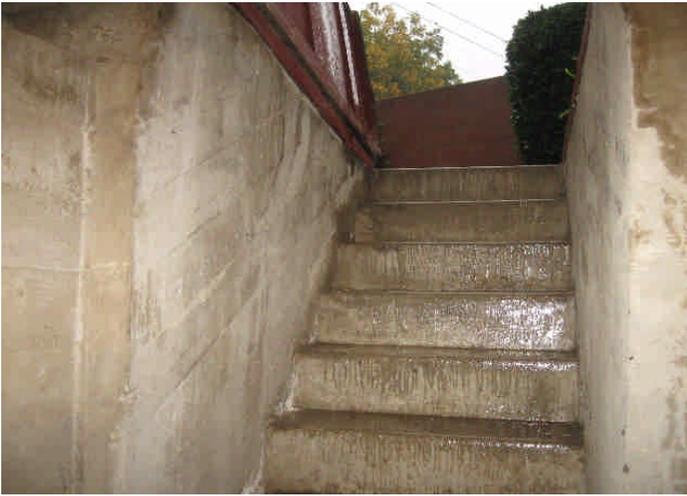
- ✓ **A handrail should be installed at the basements staircase for safety enhancement.**

A handrail should be installed at the basements staircase for safety enhancement - *Continued*

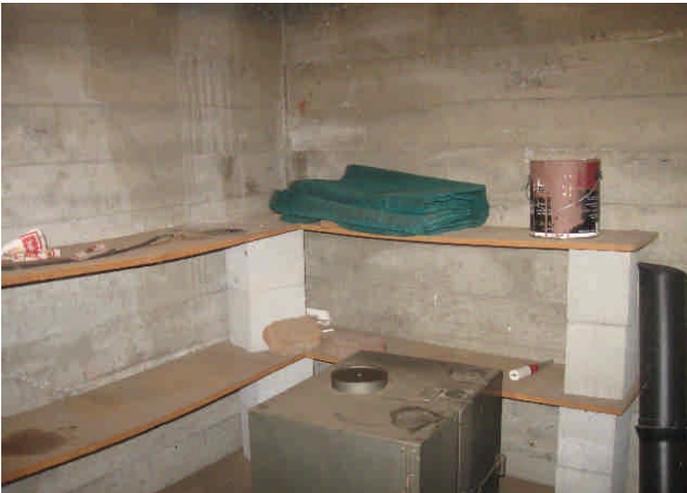
- The basement is recommended to have an automatic sump pump installed in case there is a water pipe break or spill.

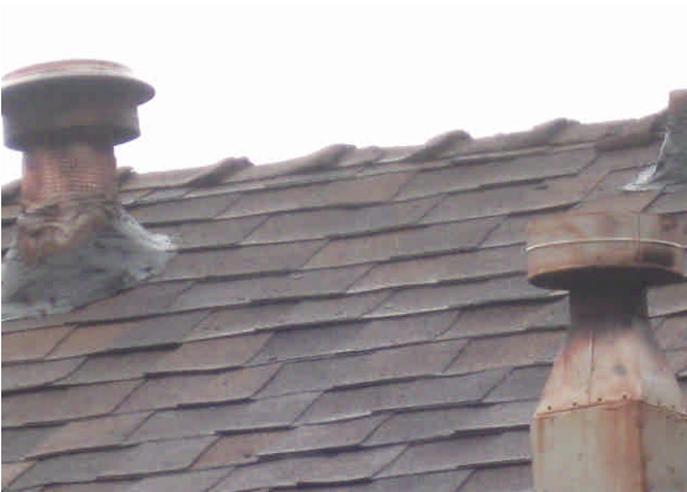
- The roof flashings are recommended to be sealed or serviced. They are comprised of metal that seals valleys and vents and other roof penetrations, recommend proper resealing flashings and painting any rusted flashings. When seal mastic repairs are made they are recommended to be coated by a paint on elastomeric roof paint to extend the life of the mastic and protect it from damaging UV light.
- Some of the roof jack vent flashings have been improperly installed with the lower part of the flashing under the shingles instead of over the lower composition shingles at the down hill side of the vent pipe, and are mastic coated over which requires yearly maintenance to prevent leaking.

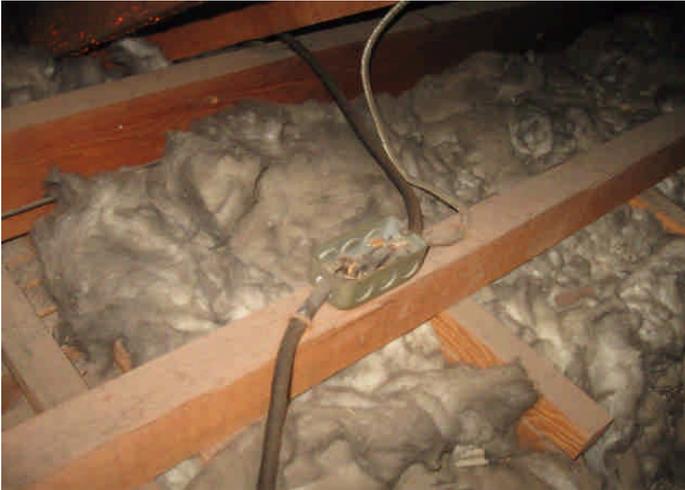
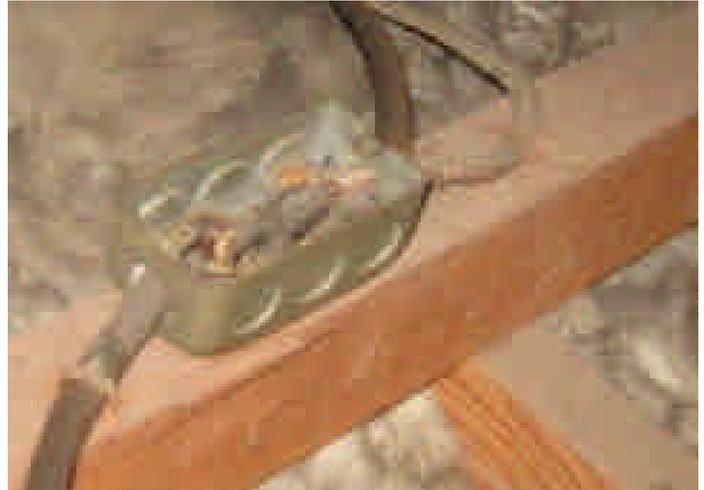
- ✓ **Open electrical junction boxes or outlets/switches without coverplates within the attic should be checked for improper wiring and properly capped so that any arcing or sparks would be contained within the box.**

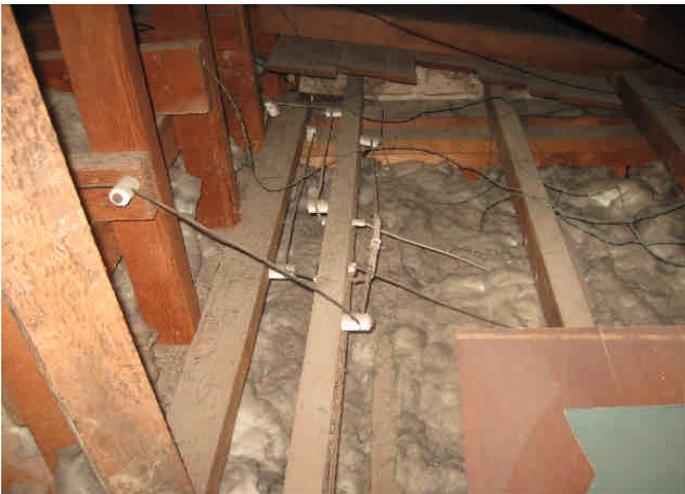
- Obsolete and suspect knob and tube wiring is present within the attic, which should be inspected and certified as safe, or replaced by a licensed electrician.

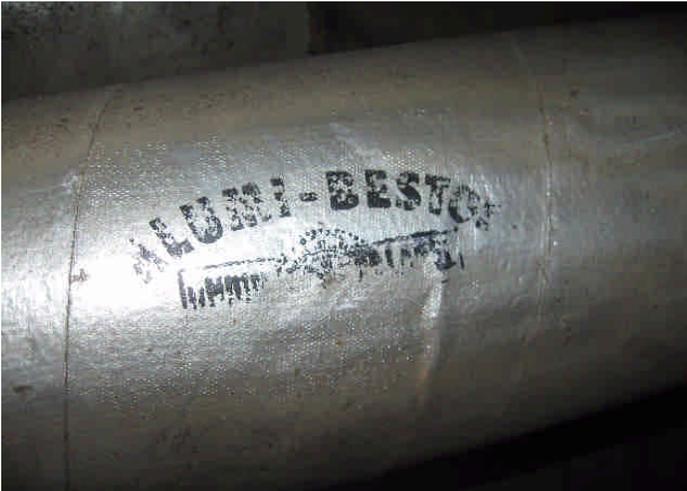
Ducting system for the heating system in the attic has insulation that is known to contain asbestos - *Continued*

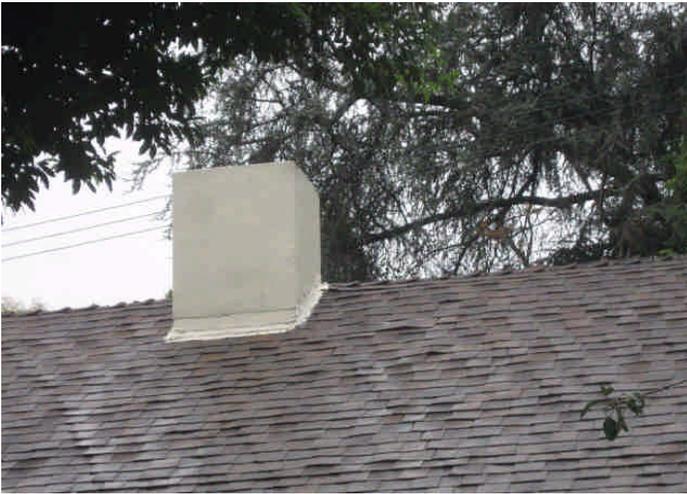
- There are no spark arrestors on the chimneys, which are required by current standards, and should be installed.

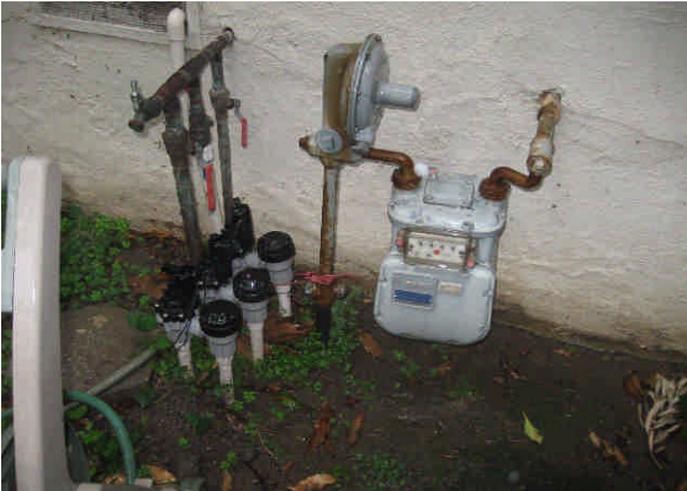
Recommend the gas shut off valve have a wrench attached or a seismic auto shut off valve installed - *Continued*

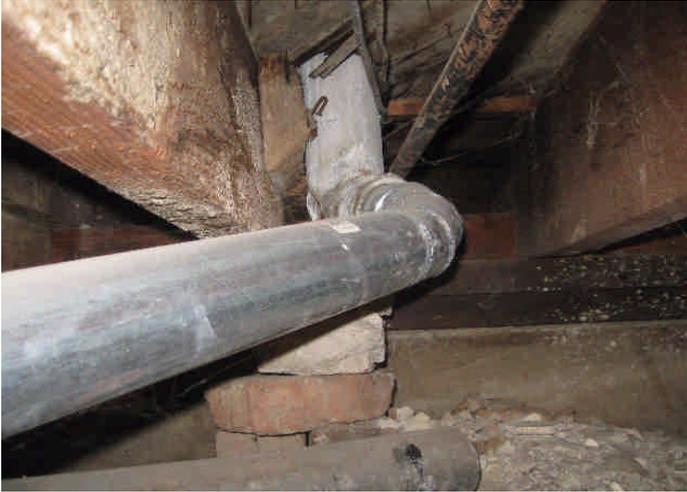
Part of the vent pipe is transite material that is known to have asbestos material in the cement pipe - *Continued*

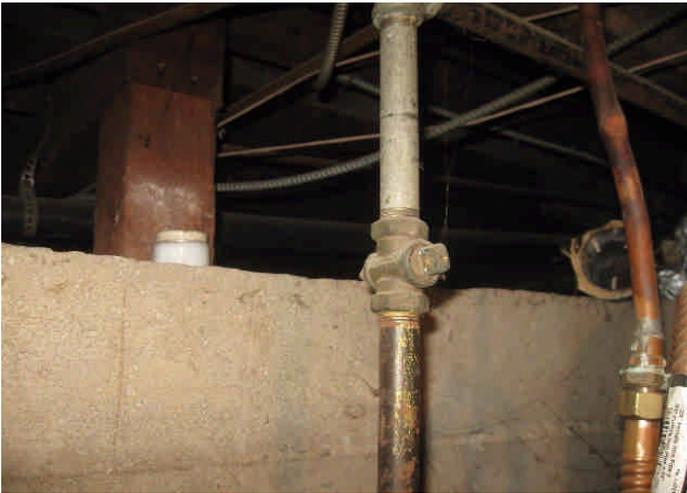
- Any structures water heaters or gas appliances that have the older style turn off type or wrench valves are recommended to be upgraded to a newer thumb turn valve that are easily turned off in an emergency.

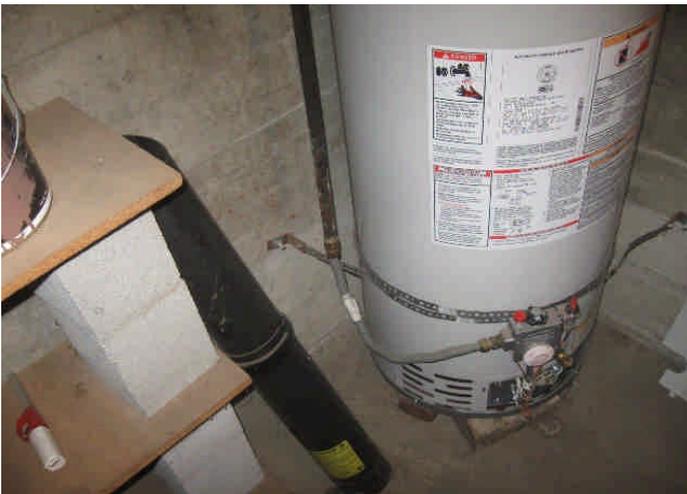
- Water heater is setting on bricks which might cause the water heater to fall off bricks during seismic activity. These bricks are on top of a concrete pad. Recommend removing the bricks and installing a stable non flammable pad.

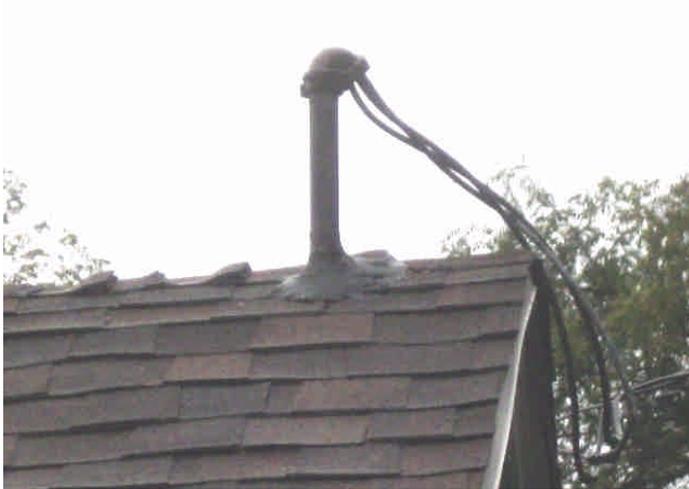
- Main electric power line has been installed closer to the roof than the currently required 18 inches above the roof on the mast pipe. Which may have acceptable at the time the structure was built, however, is recommended to be upgraded.

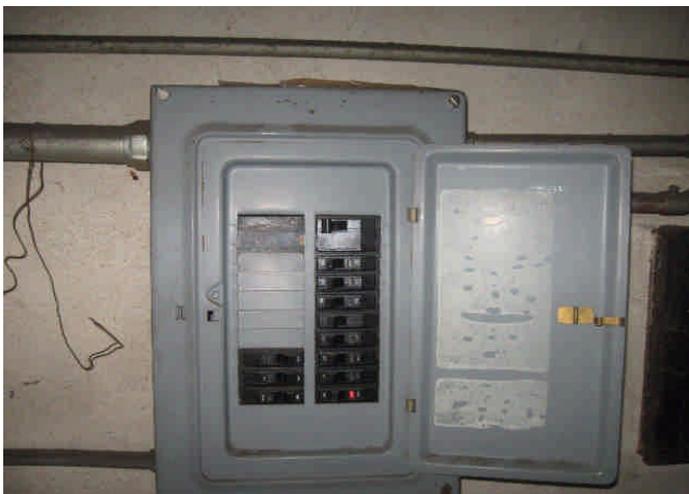
- Various circuits within the main panel are not all labeled and are recommended to be, so that the appropriate load calculations and breaker uses could be determined.

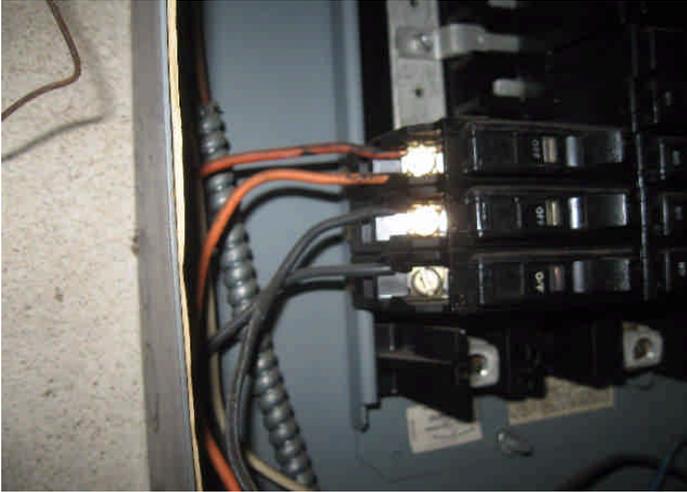
- ✓ A breaker in the main panel is serving more than one circuit. This condition should be evaluated by an electrician for installation of an additional breaker.

A breaker in the main panel is serving more than one circuit and should be serviced - *Continued*

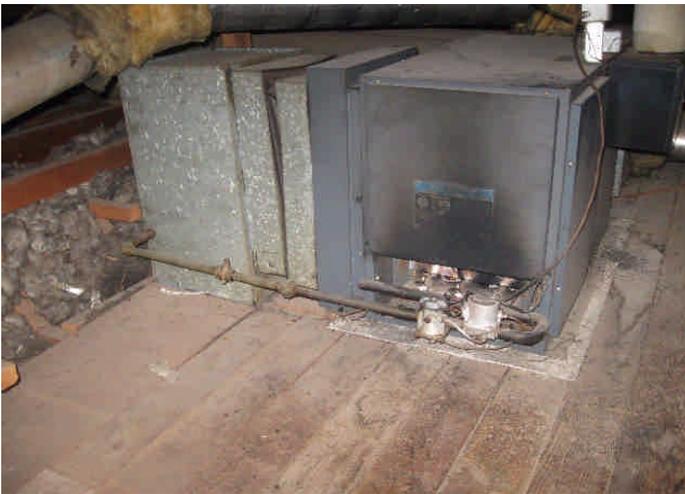
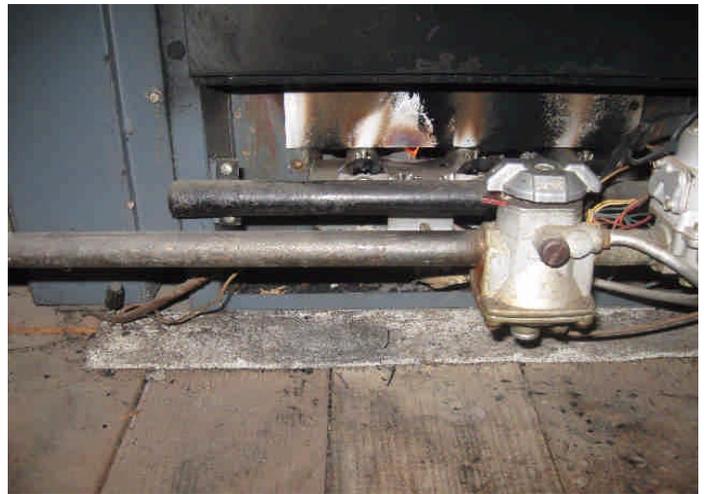
- ✓ The furnace is producing heat on demand. However, it is well beyond the commonly accepted design life of twenty years, there is rust and debris in the burn chamber, evidence of flame roll out and it should be further evaluated by a heating\cooling specialist to insure the heat exchanger and components of the system are functioning properly before the close of escrow. If the heat exchanger and components are found serviceable, it will need to be monitored more closely and is recommended to be checked by the Gas Company or a qualified HVAC specialist on a yearly basis and budgeted for replacement in the near future.

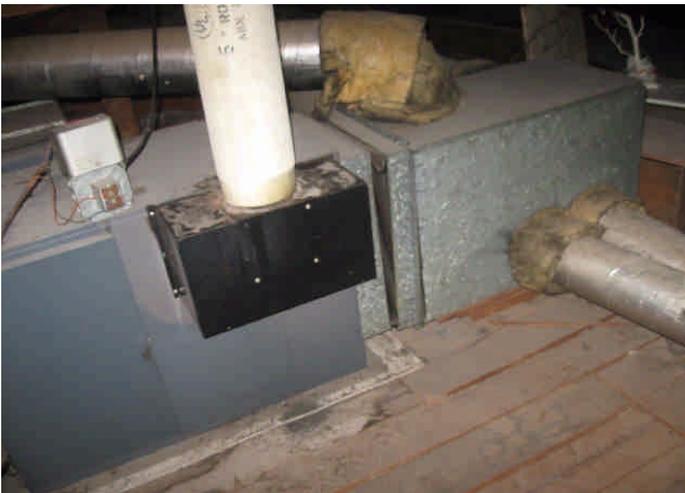
- Transite/cement vent pipe on the furnace is a known asbestos-containing material, recommend upgrading to a currently approved double wall B-vent metal pipe and having the Transite vent pipe properly removed and disposed of by a qualified specialist.

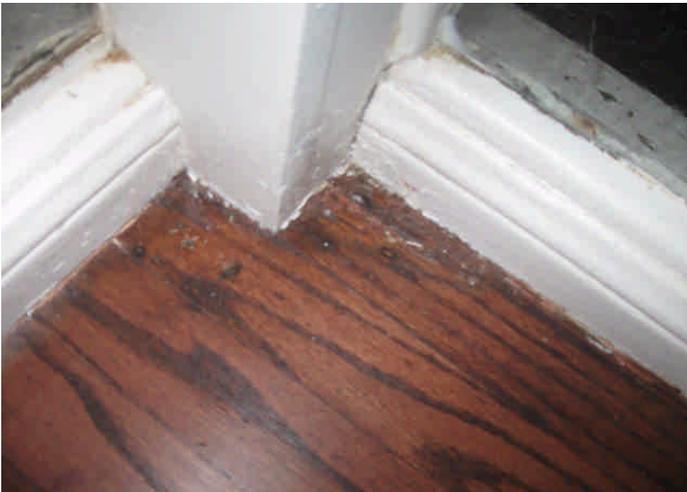
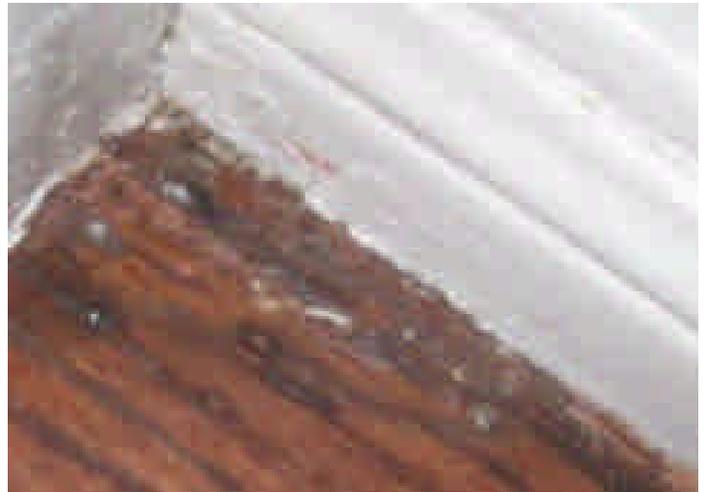
- Some moisture intrusion was noted at large picture window, however, in the heavy rain during the inspection there was no apparent leaking, recommend insuring any damage or leaking has been corrected.

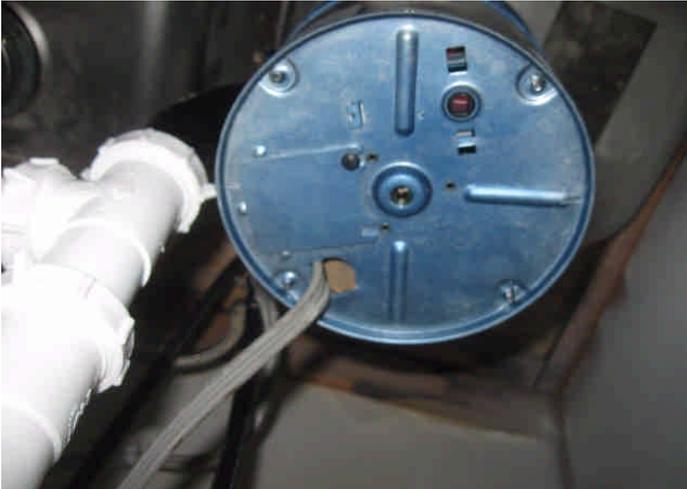
- ✓ **Garbage disposal electric cord protective clamp at bottom of the disposal is missing or loose, is considered a safety concern by the inspector and should be installed.**

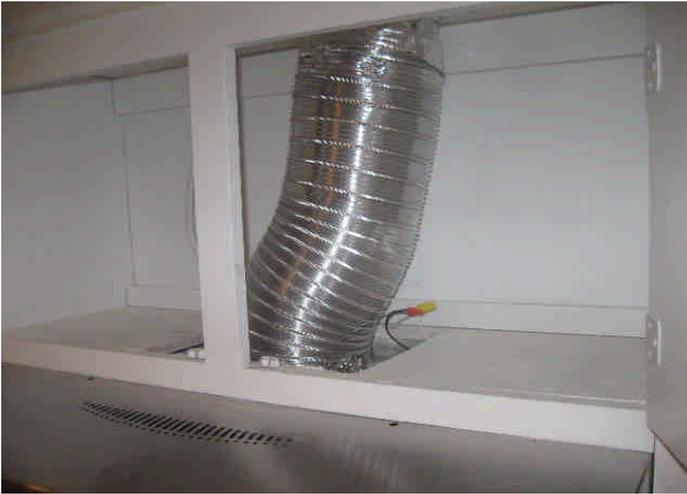
Corrugated duct for the over the stove vent fan is recommended to be changed to smooth wall - *Continued*

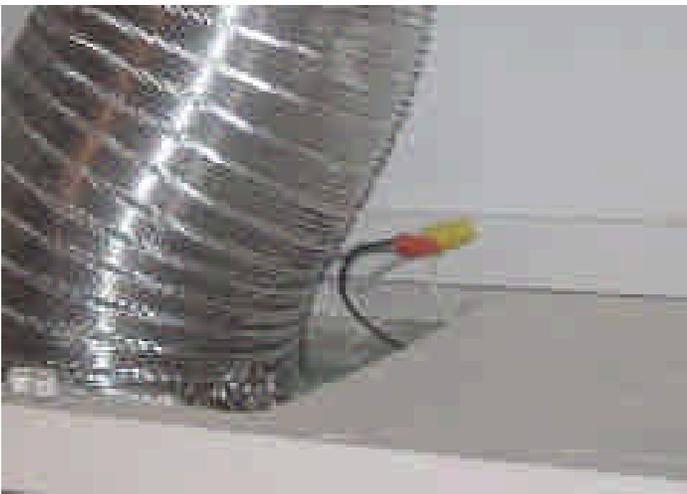
- ✓ The range hood has been improperly wired with exposed connects not properly installed in a junction box, recommend corrections by an electrical specialist.

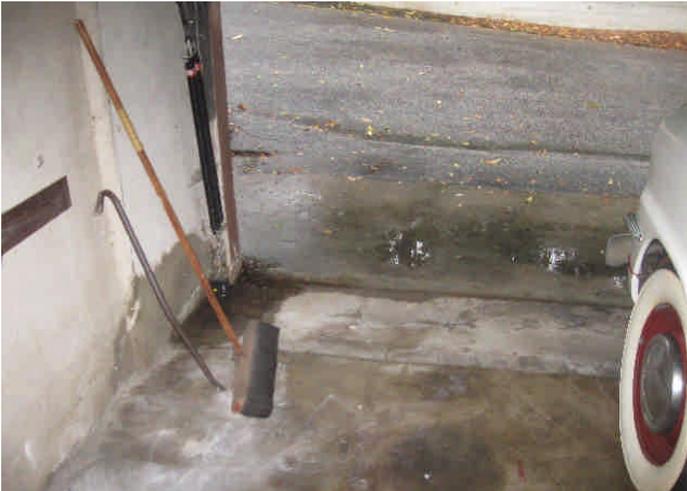
There is evidence of moisture intrusion that should be further evaluated - *Continued*

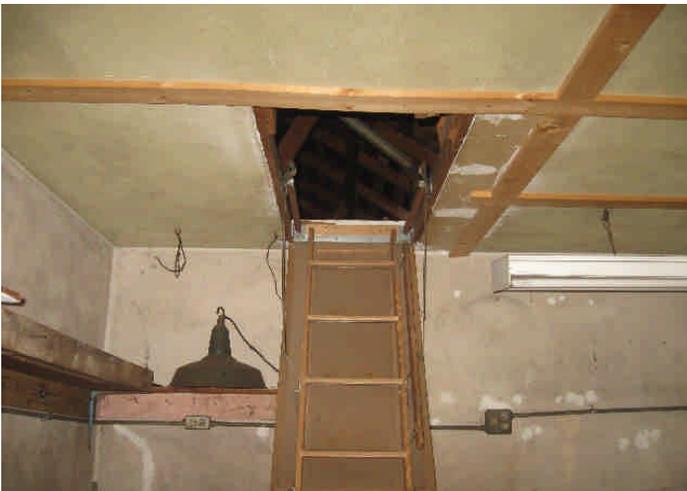
- ✓ An attic pull down ladder-door access in the garage ceiling violates the currently required firewall separation between the garage and the living quarters attic. The door-ladder cover should be firewall certified with a verification tag as meeting firewall requirements, or a fire rated self closing door between garage and attic installed. Recommend further evaluation and correction by a qualified contractor.

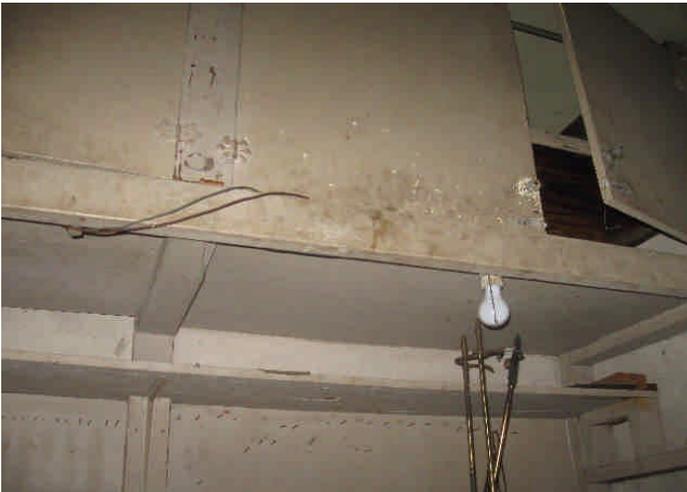
- ✓ **The garage lights have been improperly electrically wired with extension cords, no junction box or spliced connections, recommend corrections by and electrical specialist.**
