## CONFIDENTIAL INSPECTION REPORT

# 36 Shadow Ranch, La Mesa , CA

11/21/2009 2:00 pm to 5:30 pm

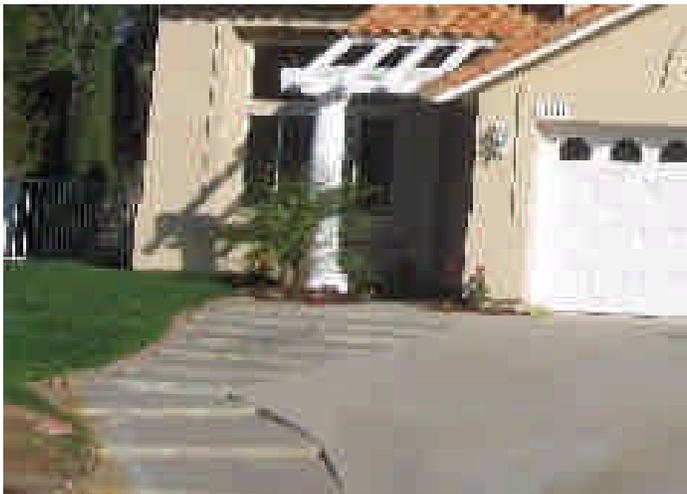
- There are offsets or irregular elevations in the walkways at the front entry from the street that could prove to be trip-hazards that you may want to mark with yellow paint for better visibility. Some rust staining on the sidewalk in this area that is recommended to be cleaned.

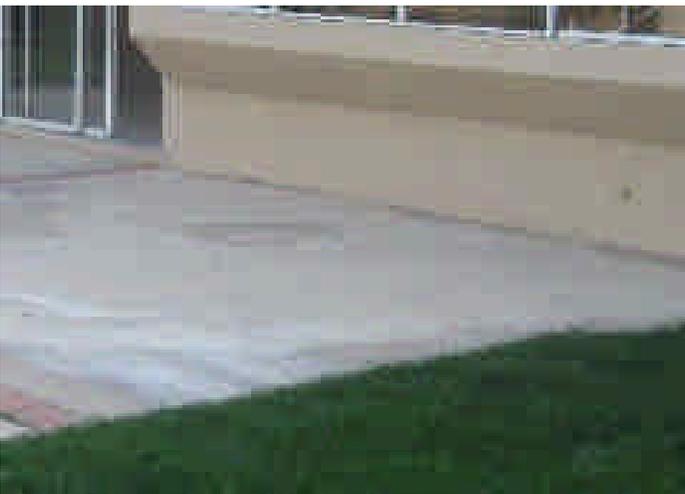
- The patio concrete has been improperly installed close or over the stucco weep screed flashing, it does appear to have slope directing water away from the walls and no evidence of moisture intrusion was found at the time of the inspection, however, moisture intrusion will remain a possibility, monitoring for moisture intrusion is recommended and particularly during rainy weather to verify no moisture intrusion is occurring.

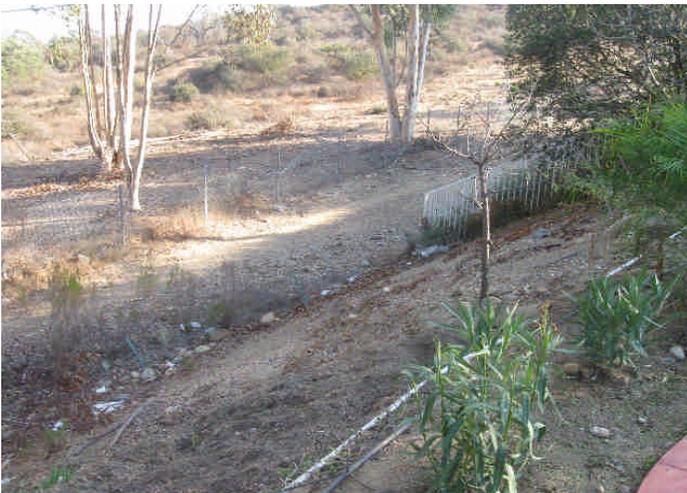
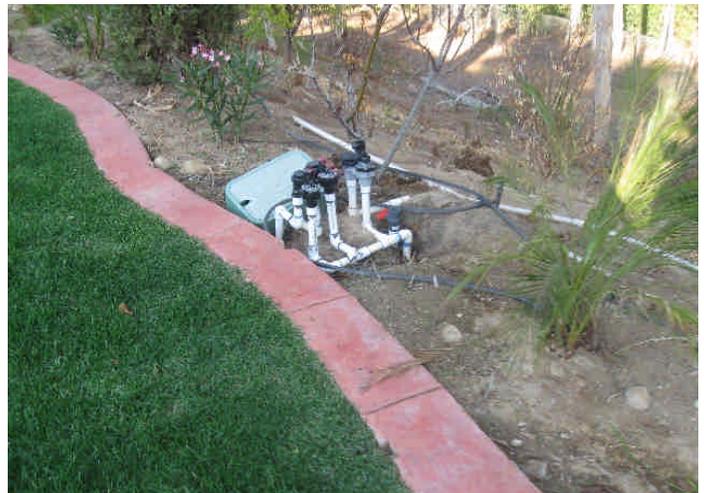
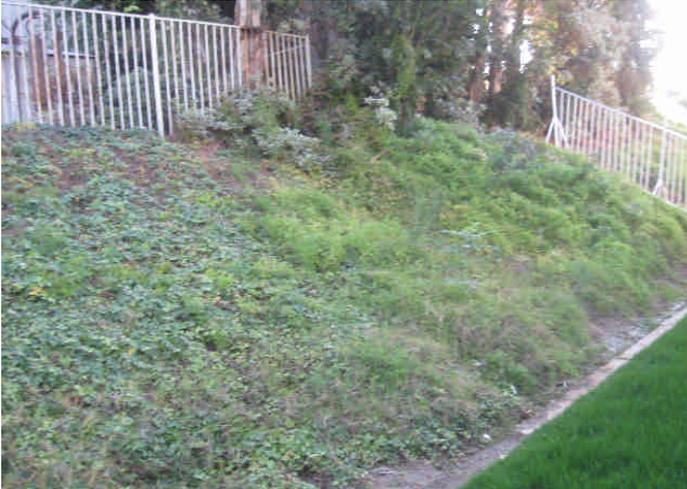
- Hillside are recommended to be monitored for proper ground cover vegetation and sprinkler systems for the prevention of possible erosion and\ or fire hazard safety.

Hillsides are recommended to be monitored for proper vegetation and sprinkler systems - *Continued*

- 1.6 - → Hillside are recommended to be monitored for proper ground cover vegetation and sprinkler systems for the prevention of possible erosion and\ or fire hazard safety.

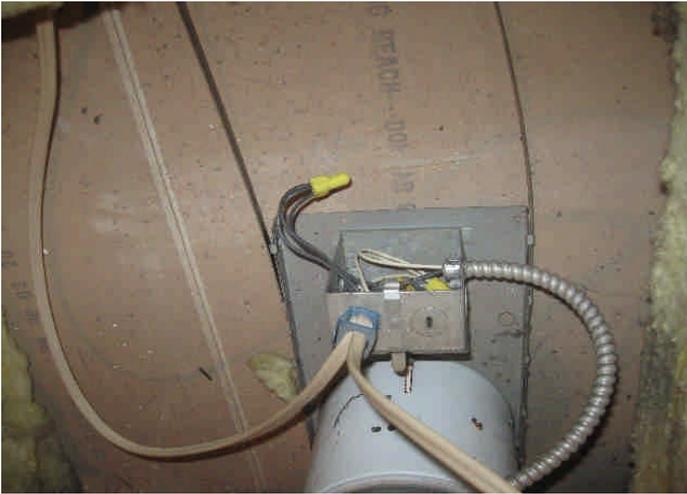
- ✓ Open electrical junction boxes or outlets/switches without coverplates within the attic should be checked for improper wiring and properly capped so that any arcing or sparks would be contained within the box.

Open electrical junction boxes within the attic should be checked and capped - *Continued*

- 3.1 - √ Open electrical junction boxes or outlets/switches without coverplates within the attic should be checked for improper wiring and properly capped so that any arcing or sparks would be contained within the box.

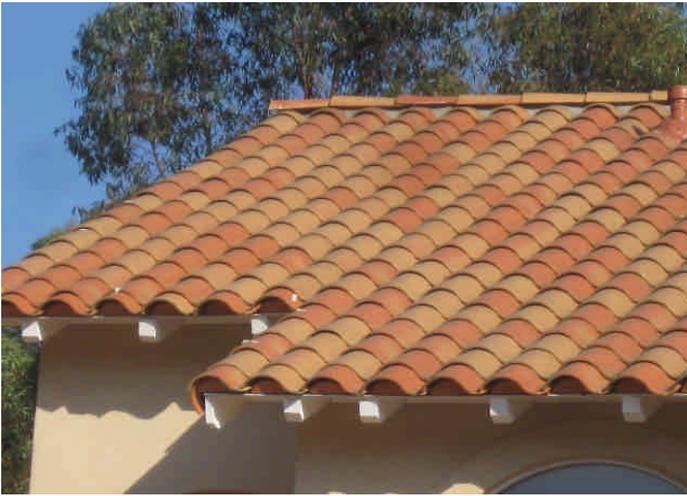
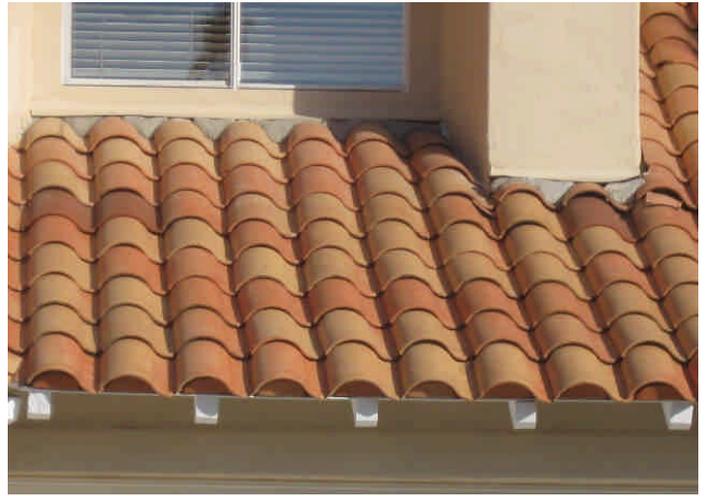
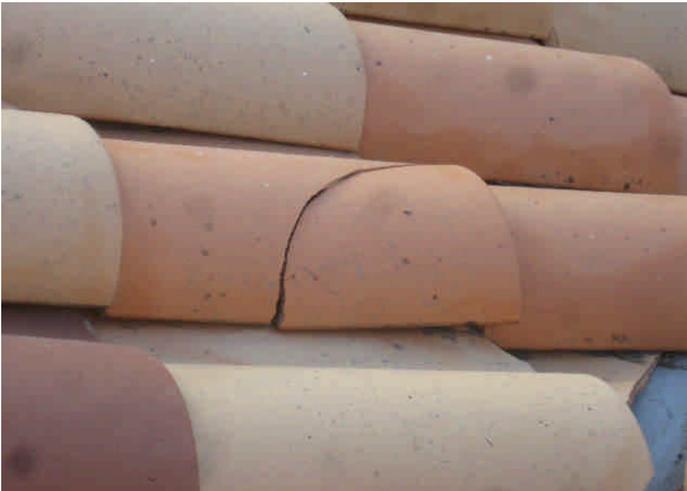
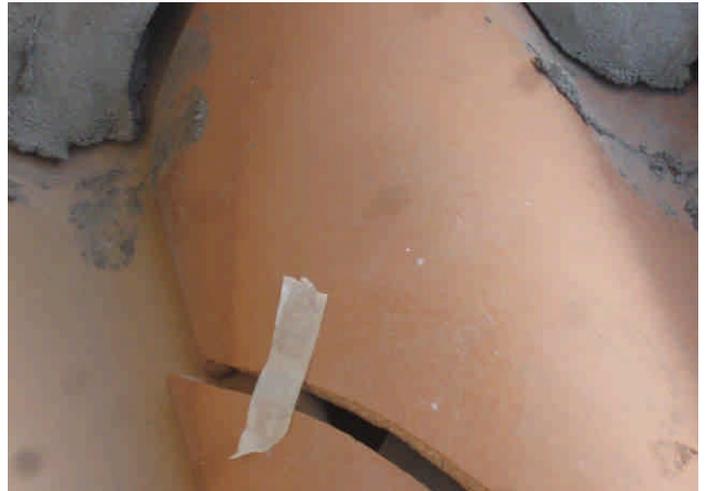
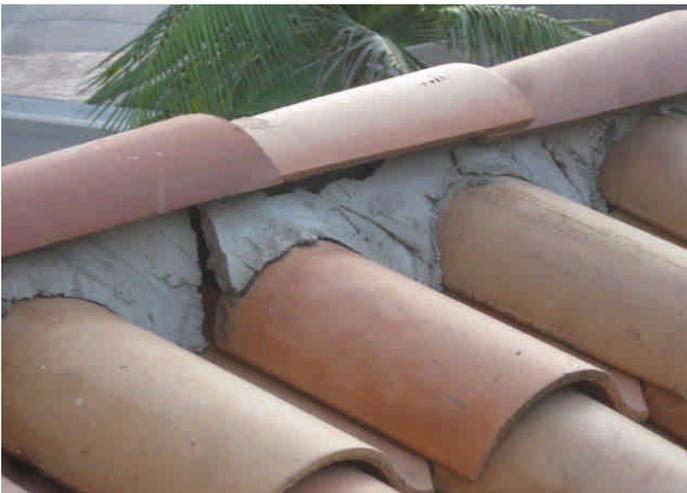
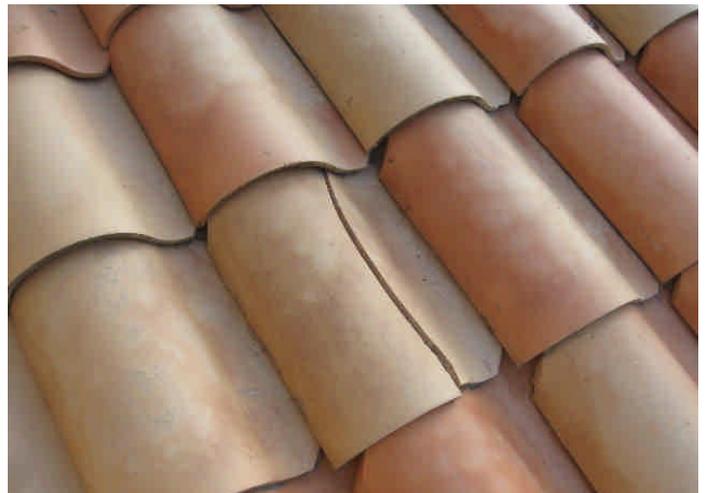
- The clay tile roof appears to be the same age as the home and is around 20 years old without any evidence of leaking found at the ceilings or attic. To avoid damaging the tiles, we elected not to walk on the roof, and inspected it instead from within the attic and from a variety of other vantage points using a ladder. There were some broken and sliding tiles noted on the roof, recommend further evaluation and corrections by a roofing specialist.

The clay tile roof appears to be the same age as the home - *Continued*

- 3.2 - → The clay tile roof appears to be the same age as the home and is around 20 years old without any evidence of leaking found at the ceilings or attic. To avoid damaging the tiles, we elected not to walk on the roof, and inspected it instead from within the attic and from a variety of other vantage points using a ladder. There were some broken and sliding tiles noted on the roof, recommend further evaluation and corrections by a roofing specialist.

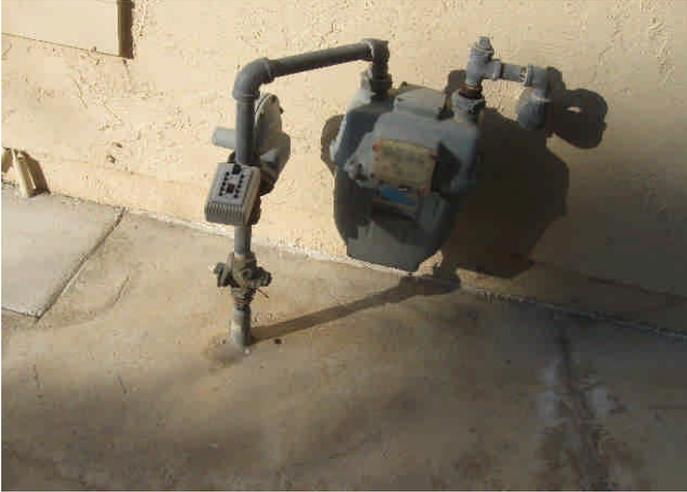
- Recommend the gas shut off valve have a wrench located at the shut off valve or a seismic auto shut off valve installed in case of emergency. Some insurance companies are now requiring that an automatic gas shut off gas valve be installed before they will insure you, this should be verified with your insurance company. They cost around \$350 to install. Some City construction jurisdictions require the auto shut off valves when a property is sold, verify with your City or insurance company on requirements before close of escrow. If the wrench only is used, it is recommended that the Gas Company's gas meter valve be verified as easily operated.

Recommend the gas shut off valve have a wrench attached or a seismic auto shut off valve installed - *Continued*

- 5.2 - ↪ Recommend the gas shut off valve have a wrench located at the shut off valve or a seismic auto shut off valve installed in case of emergency. Some insurance companies are now requiring that an automatic gas shut off gas valve be installed before they will insure you, this should be verified with your insurance company. They cost around \$350 to install. Some City construction jurisdictions require the auto shut off valves when a property is sold, verify with your City or insurance company on requirements before close of escrow. If the wrench only is used, it is recommended that the Gas Company's gas meter valve be verified as easily operated.

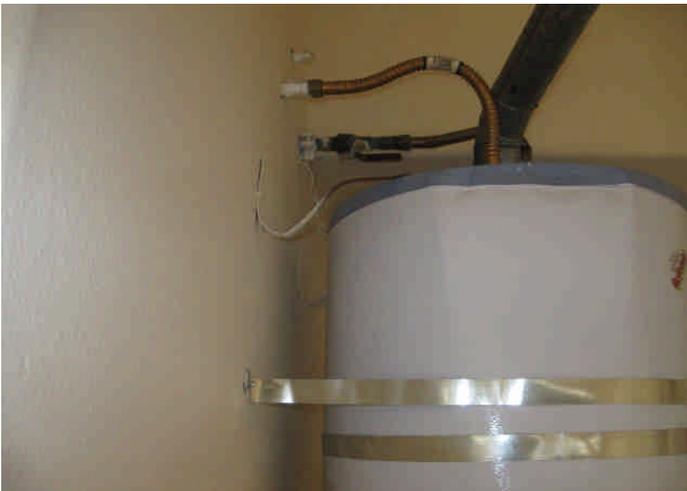
- ✓ The water heater has the seismic straps in place but is not properly blocked to the wall to prevent seismic slam during earthquake activity. This is typically a manufacturer's installation instruction requirement and is always recommended by this inspector to prevent possible damage to the water or gas lines during seismic activity. This usually is described in the seismic strap kit by the manufacturer along with wrapping the straps around the water heater to prevent side to side motion, and is usually blocking with wood at each strap location between wall and water heater with one inch of non combustibile material between the wood and the water heater if it is not a zero clearance model. Verification of zero clearance models is marked on the water heater.

- 5.5 - ∨ The water heater has the seismic straps in place but is not properly blocked to the wall to prevent seismic slam during earthquake activity. This is typically a manufacturer's installation instruction requirement and is always recommended by this inspector to prevent possible damage to the water or gas lines during seismic activity. This usually is described in the seismic strap kit by the manufacturer along with wrapping the straps around the water heater to prevent side to side motion, and is usually blocking with wood at each strap location between wall and water heater with one inch of non combustible material between the wood and the water heater if it is not a zero clearance model. Verification of zero clearance models is marked on the water heater.

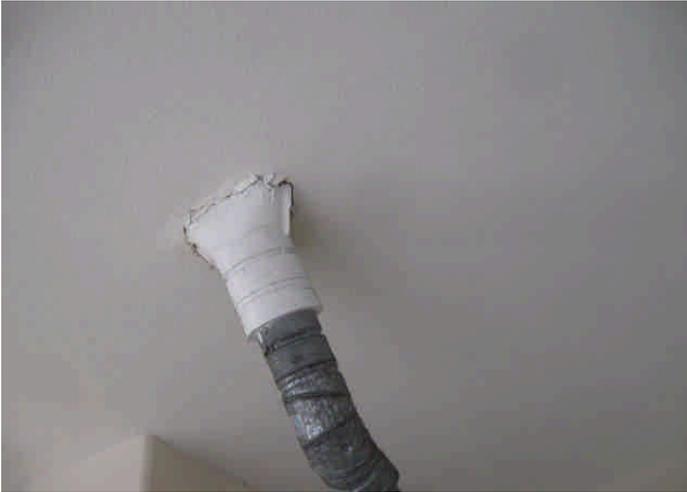
- The water heater gas vent pipe penetrates the drywall without the apparent benefit of a transition housing, double wall, b-vent pipe is required to have 1" clearance to combustible material, drywall with paper coating is considered a combustible. Sometimes the metal transition housing is covered by drywall compound and not visible, recommend verifying or clearing a one inch space around the vent pipe. The space around the vent pipe is recommended to be filled with a non combustible material or flange capped with metal.

- 5.6 - ↪ The water heater gas vent pipe penetrates the drywall without the apparent benefit of a transition housing, double wall, b-vent pipe is required to have 1" clearance to combustible material, drywall with paper coating is considered a combustible. Sometimes the metal transition housing is covered by drywall compound and not visible, recommend verifying or clearing a one inch space around the vent pipe. The space around the vent pipe is recommended to be filled with a non combustible material or flange capped with metal.

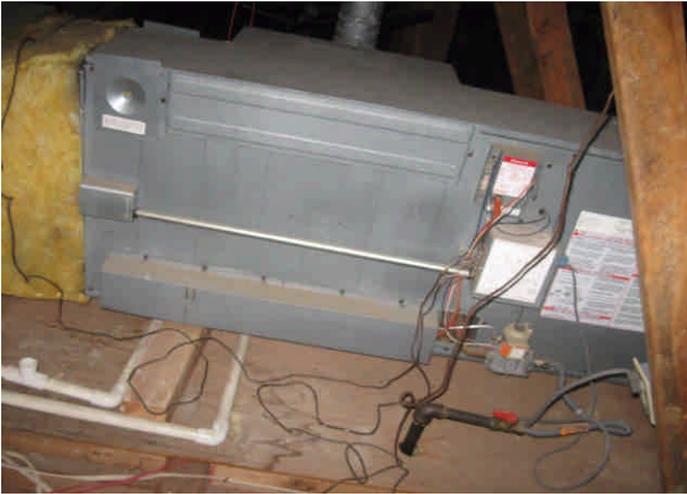
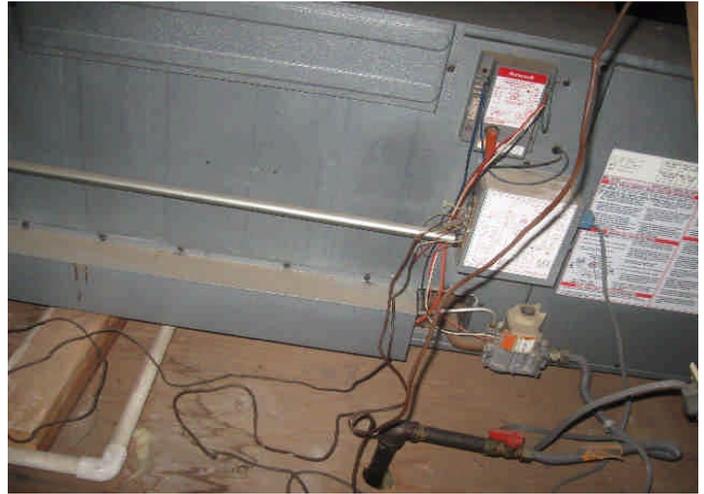
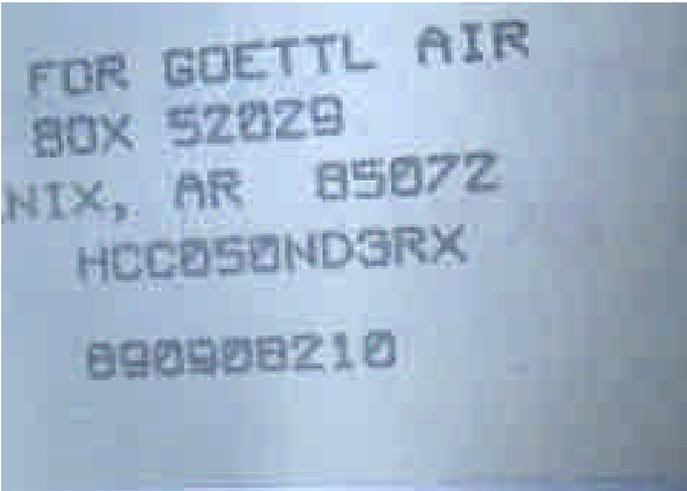
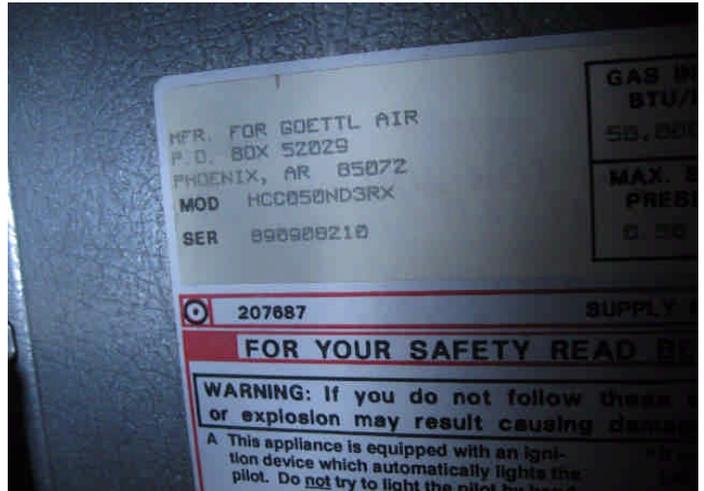
- ✓ **Furnace should be further evaluated by a qualified licensed heating-cooling specialist for possible recall, the unit is a Goettl brand unit that have some of the furnaces on recall by the CPSC, this evaluation should be done before the close of escrow in case the furnace needs to be repaired or replaced. (model # HCC050ND3RX, serial # 89090820)**

Furnace on possible recall - *Continued*

- 8.2 - √ Furnace should be further evaluated by a qualified licensed heating-cooling specialist for possible recall, the unit is a Goettl brand unit that have some of the furnaces on recall by the CPSC, this evaluation should be done before the close of escrow in case the furnace needs to be repaired or replaced. (model # HCC050ND3RX, serial # 89090820)
- 8.3 - → The clearances around the sides of the furnace in the garage closet have the furnace system closer to closet walls than is normally allowed for installation by manufacturer's instructions, recommend verifying what the manufacturers requirements are for this particular unit and the space required in the closet around the unit to insure it was properly installed. Refer to a qualified HVAC specialist for further evaluation.

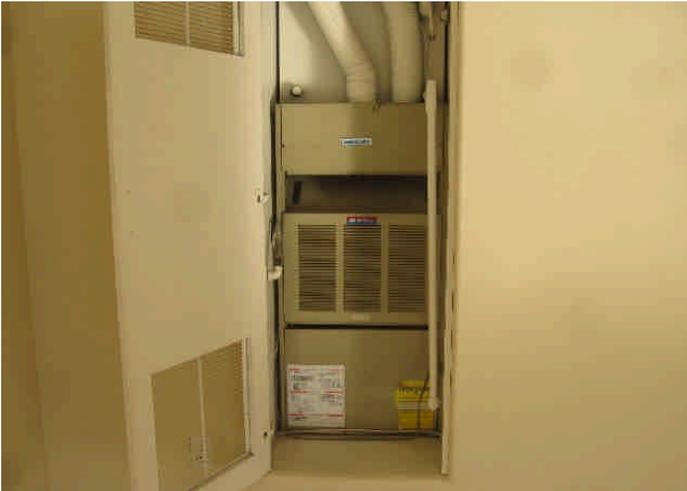
- The clearances around the sides of the furnace in the garage closet have the furnace system closer to closet walls than is normally allowed for installation by manufacturer's instructions, recommend verifying what the manufacturers requirements are for this particular unit and the space required in the closet around the unit to insure it was properly installed. Refer to a qualified HVAC specialist for further evaluation.

The clearances around the sides of the newer furnace in the closet are very close to the walls - *Continued*

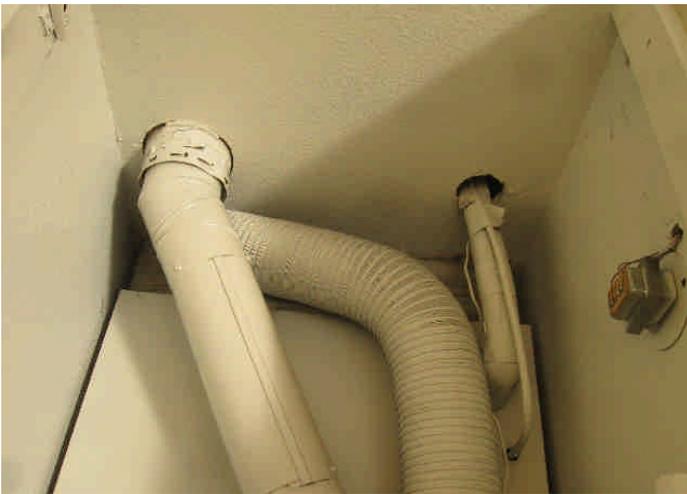
- The furnace gas vent pipe penetrates the ceiling drywall without the apparent benefit of a transition housing, double wall, B-vent pipe is required to have 1" clearance to combustible material, drywall is with paper coating is considered a combustible. Sometimes the metal transition housing is covered by drywall compound and not visible, recommend verifying or clearing a one inch space around the vent pipe. Installing a metal cap ring or transitional housing is recommended.

- 8.4 - → The furnace gas vent pipe penetrates the ceiling drywall without the apparent benefit of a transition housing, double wall, B-vent pipe is required to have 1" clearance to combustible material, drywall is with paper coating is considered a combustible. Sometimes the metal transition housing is covered by drywall compound and not visible, recommend verifying or clearing a one inch space around the vent pipe. Installing a metal cap ring or transitional housing is recommended.

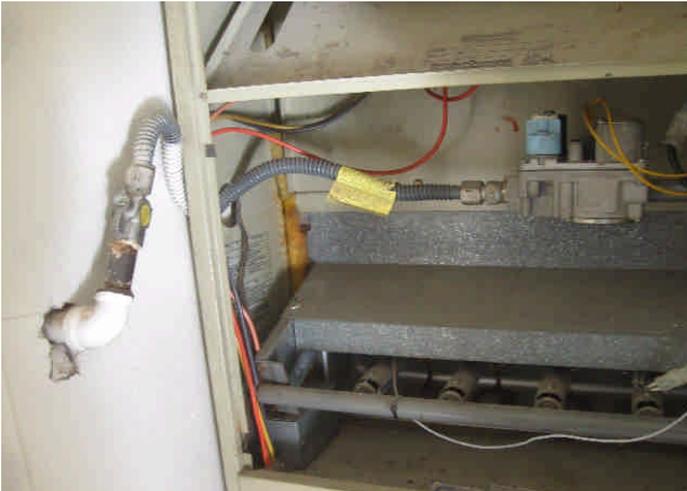
- You should be aware that the gas feed line that passes through the furnace sidewall is flexible, and is required by current codes or manufacturer's requirements to be rigid until it passes beyond the furnace, and then flexible to the point where it connects to the gas valve. This can possibly cause vibration or seismic damage to the thin walled flex gas line. This condition is recommended to be corrected by an HVAC contractor or gas appliance specialist.

The gas feed line that passes through the furnace sidewall is flexible and should be rigid - *Continued*

- 8.5 - → You should be aware that the gas feed line that passes through the furnace sidewall is flexible, and is required by current codes or manufacturer's requirements to be rigid until it passes beyond the furnace, and then flexible to the point where it connects to the gas valve. This can possibly cause vibration or seismic damage to the thin walled flex gas line. This condition is recommended to be corrected by an HVAC contractor or gas appliance specialist.

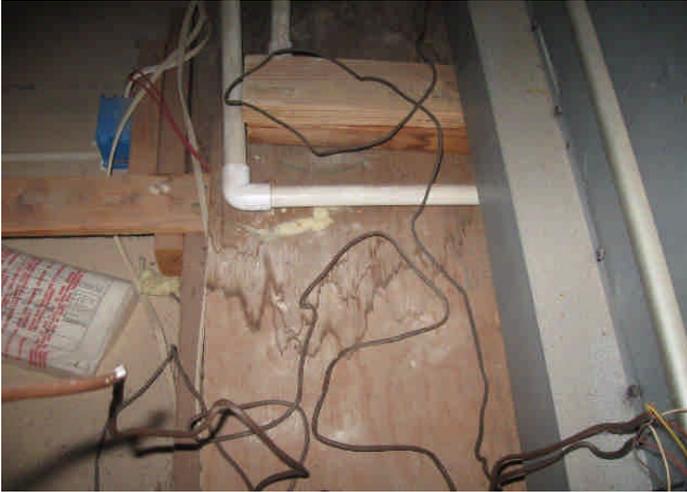
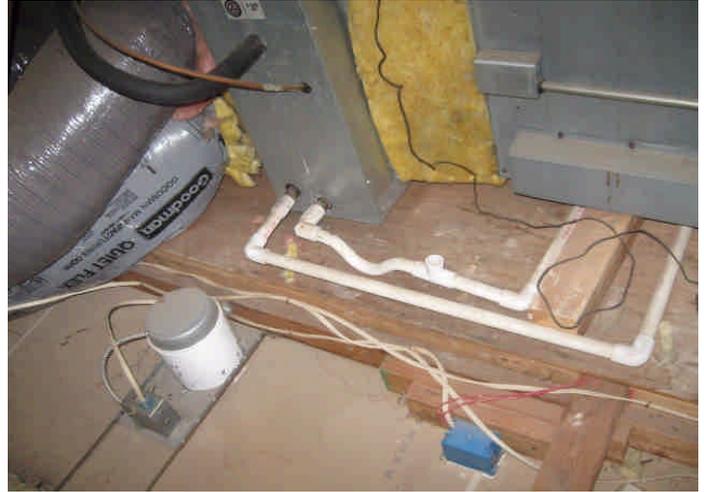
- The attic AC evaporator coil in the attic has both primary and secondary drain lines in place, however, an auxiliary pan is not in place and is recommended to be installed to help prevent a possible leak under the unit in the attic. Some construction jurisdictions may not require the auxiliary drain pan under the unit at time of construction, however, it is a recommended upgrade to help prevent a possible water spill in the attic that might extend to the ceiling in the home. There were moisture stains around the condensate pipes in the attic.

Auxiliary drain pan not in place however there are primary and secondary drain pipes in place - *Continued*

- 8.7 - → The attic AC evaporator coil in the attic has both primary and secondary drain lines in place, however, an auxiliary pan is not in place and is recommended to be installed to help prevent a possible leak under the unit in the attic. Some construction jurisdictions may not require the auxiliary drain pan under the unit at time of construction, however, it is a recommended upgrade to help prevent a possible water spill in the attic that might extend to the ceiling in the home. There were moisture stains around the condensate pipes in the attic.

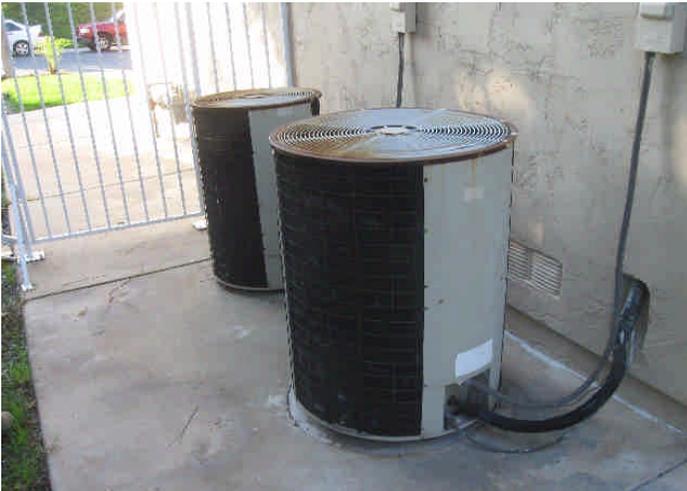
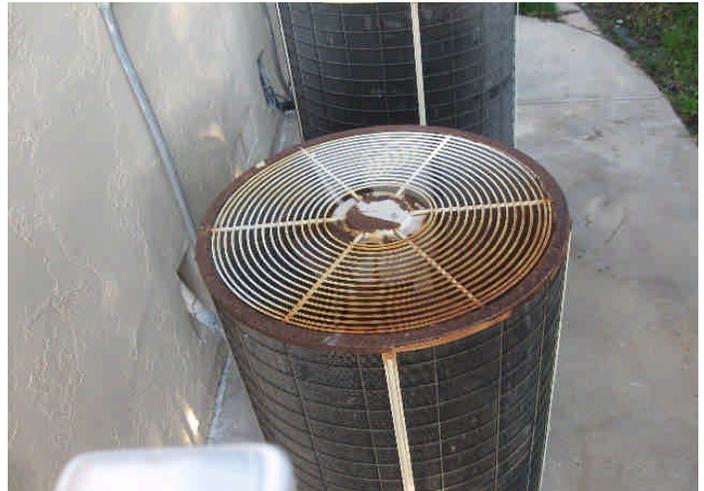
- The air conditioning/heating system are both cooling, however, they are recommended to be serviced to keep the systems in peak condition, there is rust and debris in the 20 year old units, recommend the AC condensers be cleaned, refrigerant levels checked and the evaporators verified as having the condensation draining properly and with good air flow through the system. This is especially important when the system is over five years old and will keep the system functioning properly when needed during the warmer times of the year. This is normal maintenance recommended at least every two years with the filters changed every couple of months depending on use of the system.

- 8.8 - → The air conditioning\heating system are both cooling, however, they are recommended to be serviced to keep the systems in peak condition, there is rust and debris in the 20 year old units, recommend the AC condensers be cleaned, refrigerant levels checked and the evaporators verified as having the condensation draining properly and with good air flow through the system. This is especially important when the system is over five years old and will keep the system functioning properly when needed during the warmer times of the year. This is normal maintenance recommended at least every two years with the filters changed every couple of months depending on use of the system.

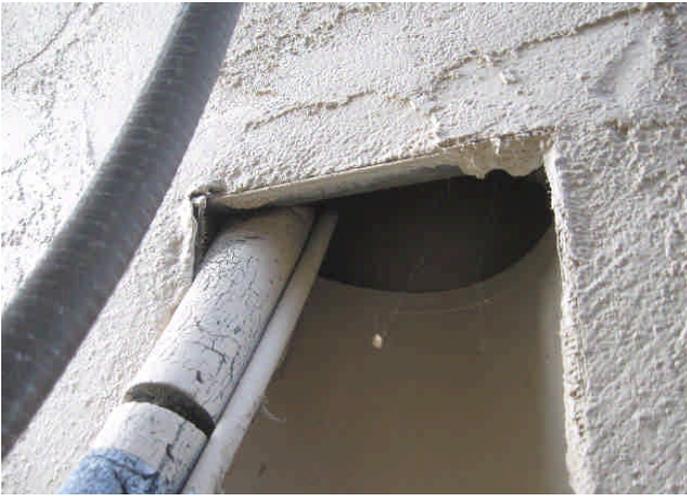
- Refrigerant lines from the AC condenser are not properly sealed where they enter exterior wall and should be sealed to prevent possible rodent entry into the walls\attic of structure.

Refrigerant lines from the AC condenser are not properly sealed where they enter exterior wall - *Continued*

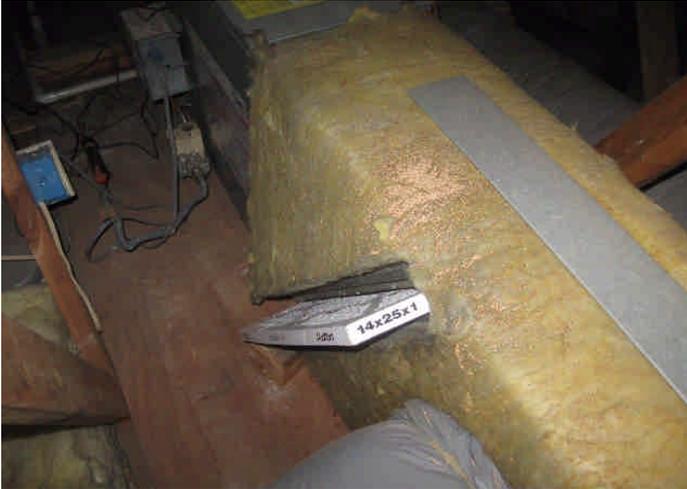
recommended to be corrected.

8.10 - → The filter for the attic HVAC is not properly secured or the correct size and is by passing un filtered air and is recommended to be corrected.

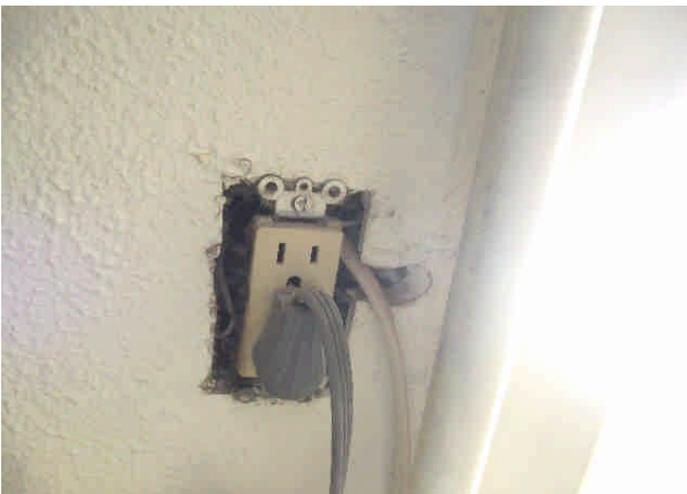
- ✓ There is improper electrical wiring noted in the hvac-furnace closet that is recommended to be corrected. (romex wire improperly installed into the garage closet HVAC 120 volt electric outlet, recommend corrections by an electrical specialist and a cover plate installed.)

8.13 - √ There is improper electrical wiring noted in the hvac-furnace closet that is recommended to be corrected. (romex wire improperly installed into the garage closet HVAC 120 volt electric outlet, recommend corrections by an electrical specialist and a cover plate installed.)

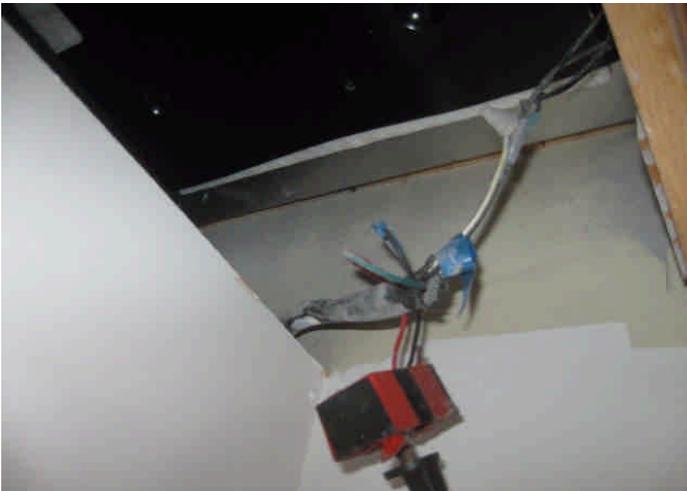
- ✓ The kitchen exhaust fan responded to the controls. However, the control switch under the cabinet has been improperly installed with electrical connections outside of an electrical junction box. Recommend corrections by an electrical specialist.

10.2 - √ The kitchen exhaust fan responded to the controls. However, the control switch under the cabinet has been improperly installed with electrical connections outside of an electrical junction box. Recommend corrections by an electrical specialist.

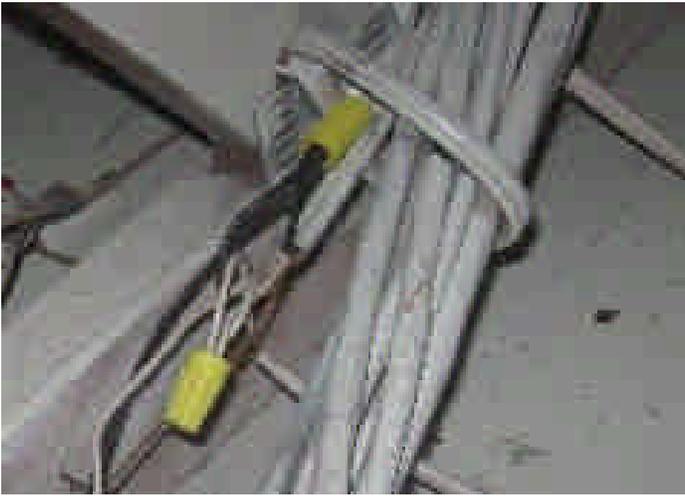
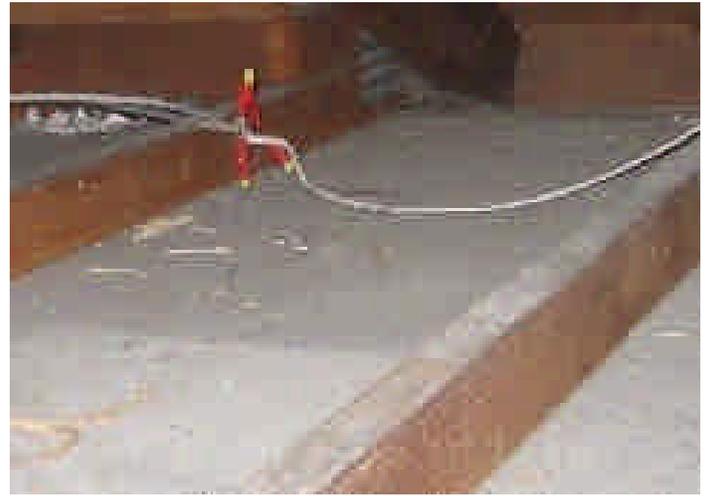
Exposed or taped splices in some of the wiring in the garage is recommended to be corrected - *Continued*

16.3 - √ Exposed or taped splices, no junction boxes in some of the wiring in the garage attic is recommended to be corrected.
