CONFIDENTIAL INSPECTION REPORT

1026 Paseo Rosarito, San Juan Capistrano, CA

10/6/2009 10:00 am to 12:30 pm

SUMMARY REPORT

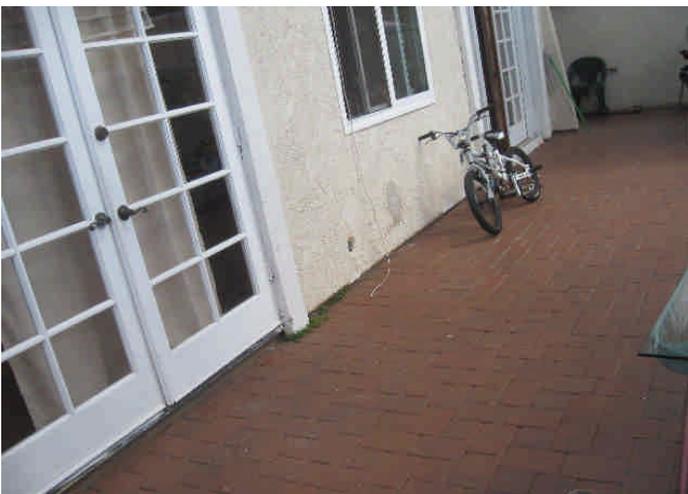
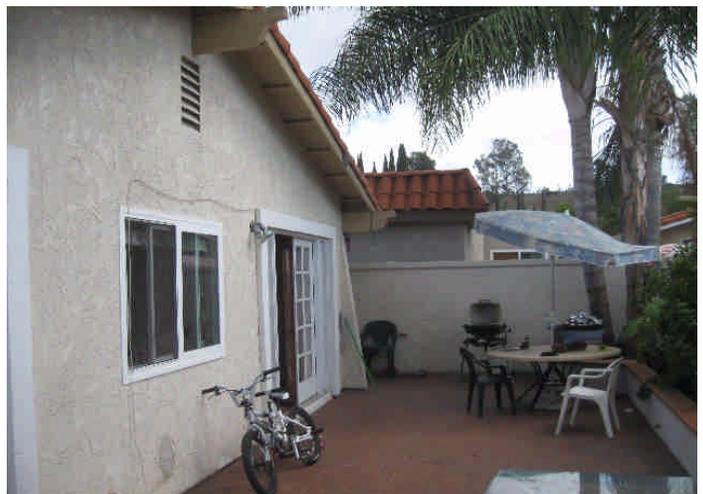
- Patio masonry pad does not appear to have any unusual displacement or cracking, it appears to drain away from the foundation, this should be verified during heavy rains.

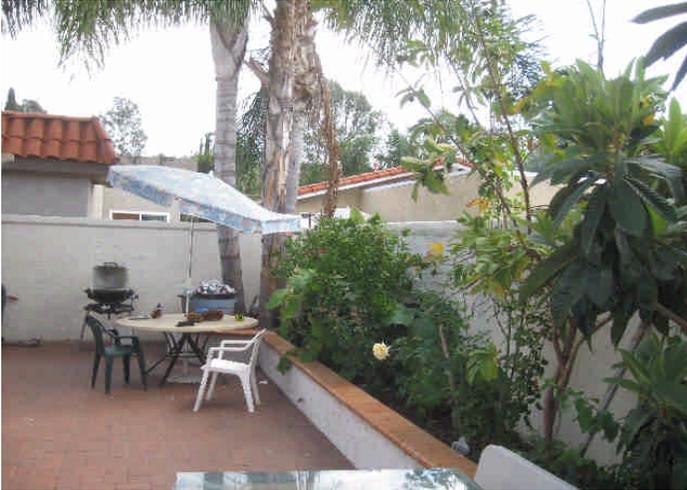
- The fences and gates did not appear to have any unusual damage or deterioration.

- Portions of the fences are obscured by foliage or other material, which prevents a thorough inspection and can cause damage to the fences, recommend monitoring to prevent possible damage to fences.

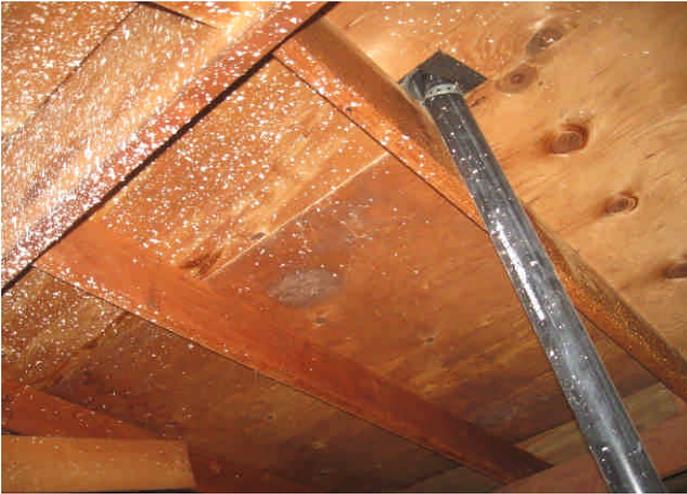
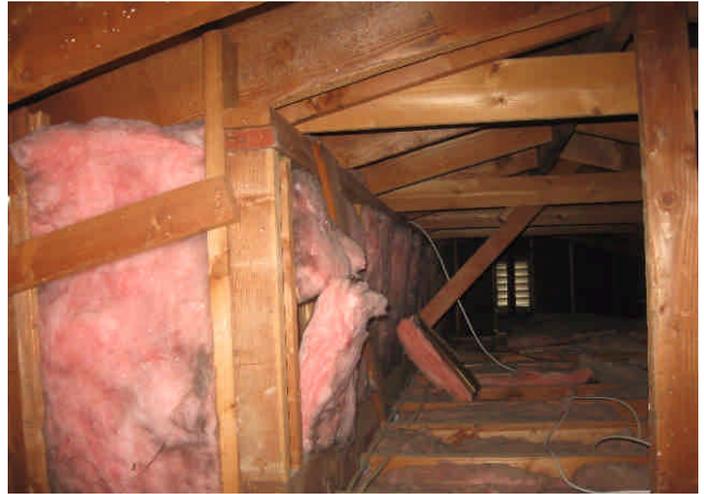
The visible portions of the framing appear to be in acceptable condition - *Continued*

- The visible portions of the framing are in acceptable condition, and would conform to the standards of the year in which they were constructed. Current construction methods would possibly require additional brackets and metal clips to assist in holding the vertical support members in place, however, no supports were found to be displaced during the inspection.

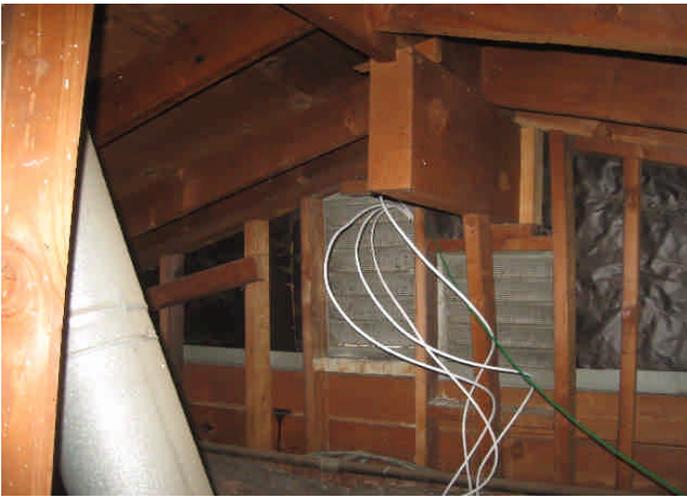
- Ventilation within the attic is provided by a combination of eave, dormer, turbine, or gable vents, and should be adequate.

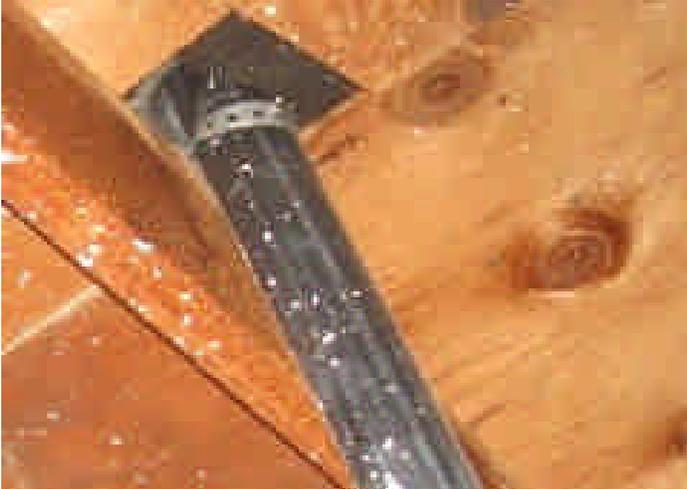
- The visible plumbing vents found had no apparent damage at time of the inspection.

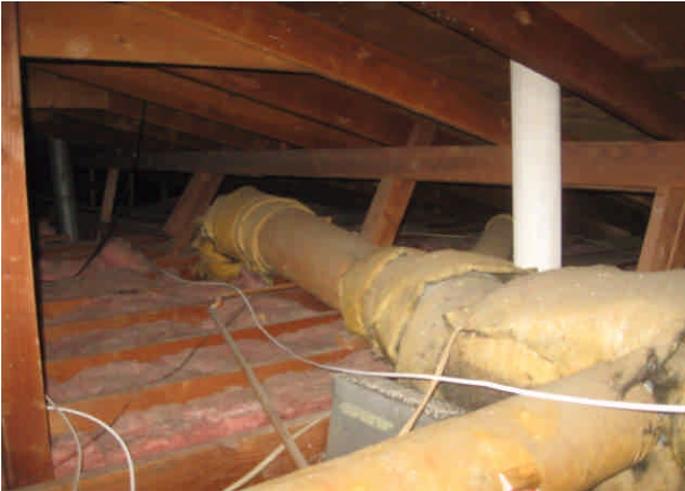
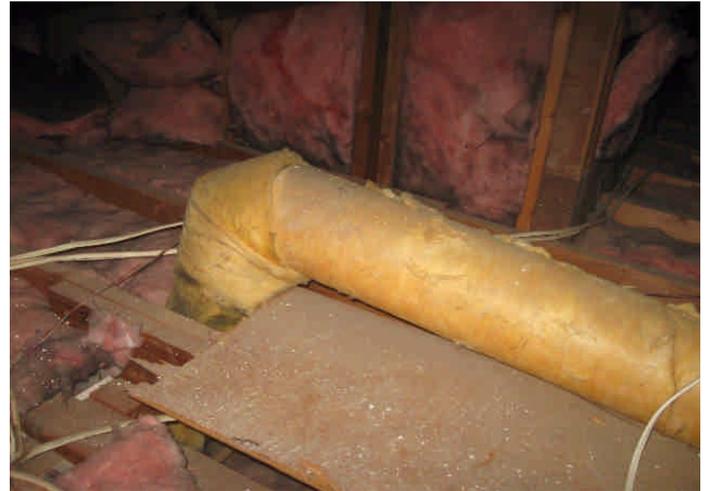
- The visible heating-cooling ducts in the attic did not appear to have any damage at time of the inspection.
- This age building and heating-cooling system can contain asbestos, asbestos inspection and laboratory testing for asbestos is not part of this inspection, recommend upgrading any asbestos materials to newer approved products with any asbestos properly removed and disposed of.
- The supply ducts are compressed fiberglass. They cannot be cleaned easily, are very easily damaged, and can be problematic to hyper-allergenic people, and although they may appear to be rigid they can be easily bent or compressed, and should be treated with care. However, no evidence of damage was found at the

time of the inspection.

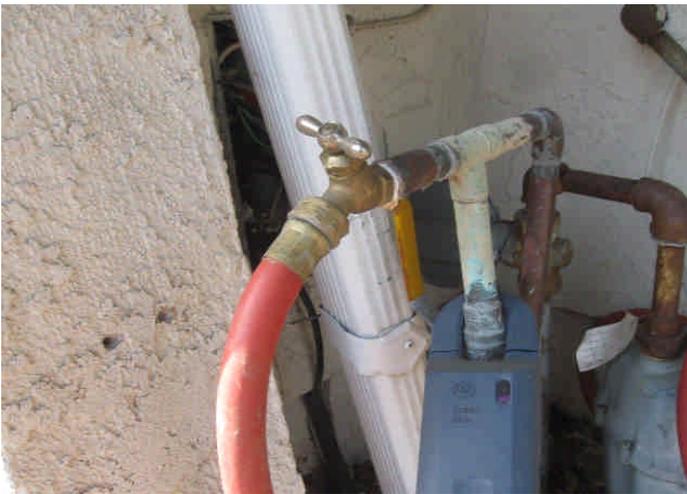
- Water main shut off is a newer style ball valve.
- The main water shut-off valve is located at the front of the building.

- Water pressure is within normal operating range between 40 and 80 psi.

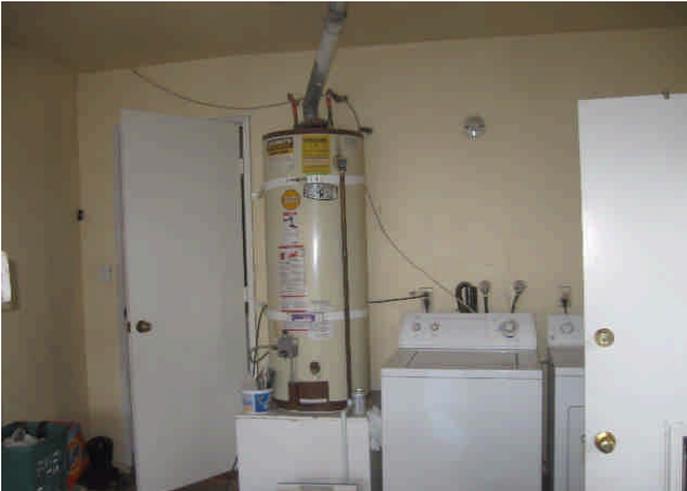
The property is served by a gas water heater located in the garage - *Continued*

- The water heater was producing hot water at the time of the inspection.
- The water heater is heating water, however, is older and past the normal useful life expectancy of a water heater. Normally water heaters last 10 to 15 years under ideal conditions. Older water heaters will not be as efficient as newer water heaters and because of mineral deposit build up will run out of hot water more quickly. Recommend budgeting for replacement in the near future.
- Hot water is provided by an approximately 17 year old, 50 gallon gas water heater that is located in the garage.

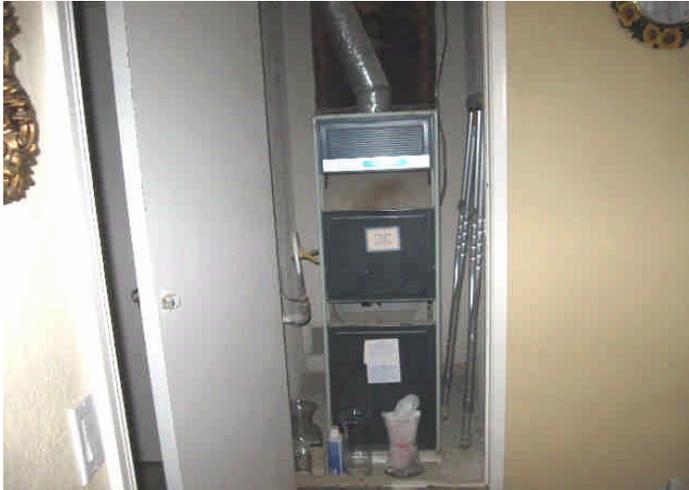
- Heat is provided by a forced air furnace approximately 30 years old, located in hall closet.

- The furnace is producing heat on demand. However, it is beyond the commonly accepted design life of twenty years and is recommended to be further evaluated by a heating\cooling specialist to insure the heat exchanger and components are functioning properly before the close of escrow. If the heat exchanger and components are found serviceable, it will need to be monitored more closely and is recommended to be checked by the Gas Company or a qualified HVAC specialist on a yearly basis and budgeted for replacement in the near future.
