## CONFIDENTIAL INSPECTION REPORT

### Older Home Example

511 Broadway, Whittier, CA

12/12/2009 2:30 pm to 5:00 pm

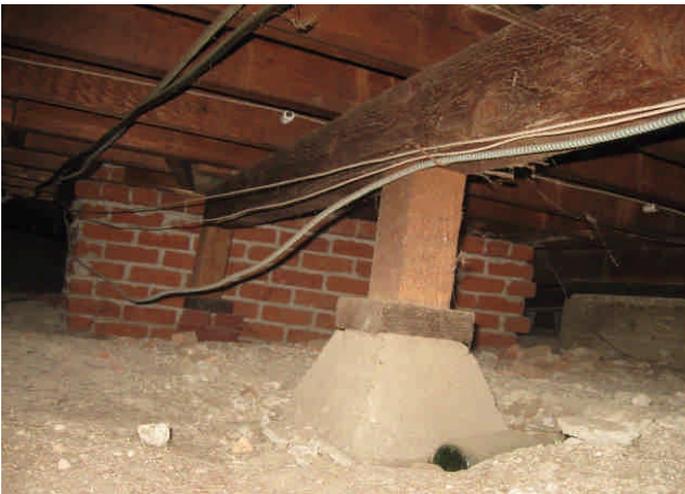
- Raised concrete foundation with bolts from walls to foundation typical of the time the structure was built were noted under the structure.
- Pier posts were not t-strapped to prevent kick out during seismic activity, recommend upgrading with t-strap anchors and screws even though they may not have been required when the structure was built.

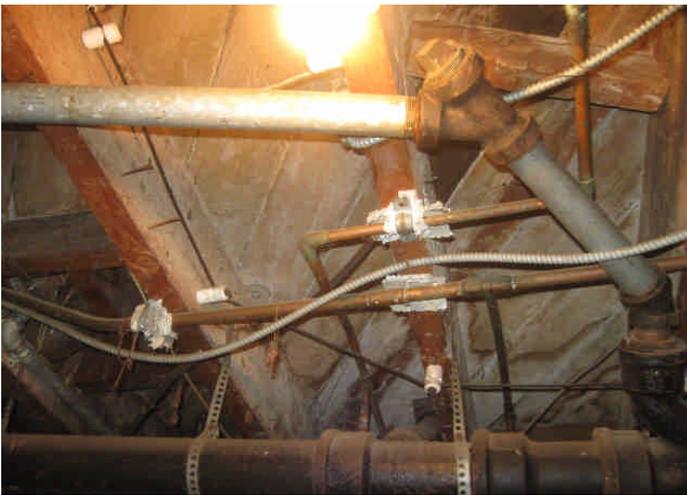
- There was no apparent leaking from the visible water supply or drain plumbing under the structure at the time of the inspection.

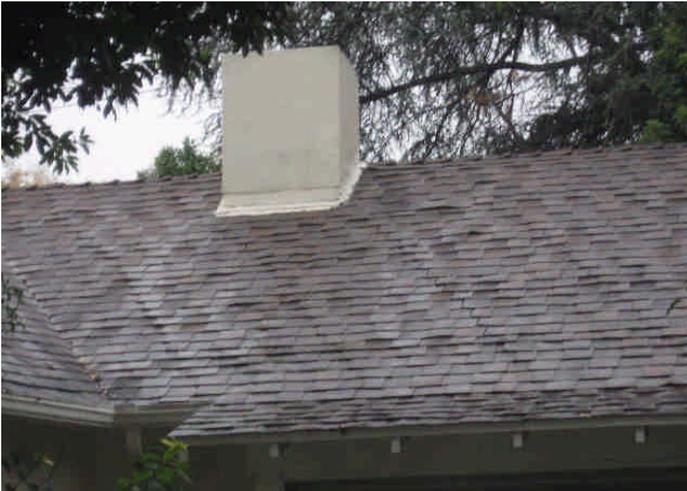
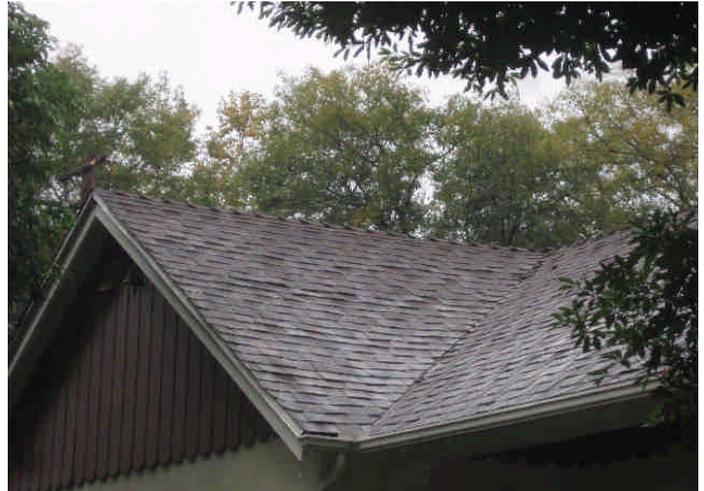
The composition shingle roof is layered and appears to be approximately five to ten years old - *Continued*

- The composition shingle roof over a wood shingle roof appears to be approximately five to ten years old on a roof system that will normally last around 20 to 30 years with good maintenance, but this is just an estimate and you should request the installation permit from the sellers or obtain them from the City, which will reveal its exact age and any warranty guarantee that might be applicable. No apparent damage or leaking was found at time of the inspection during a heavy rain storm. Recommend regular inspection of roof and regular maintenance of the flashings.

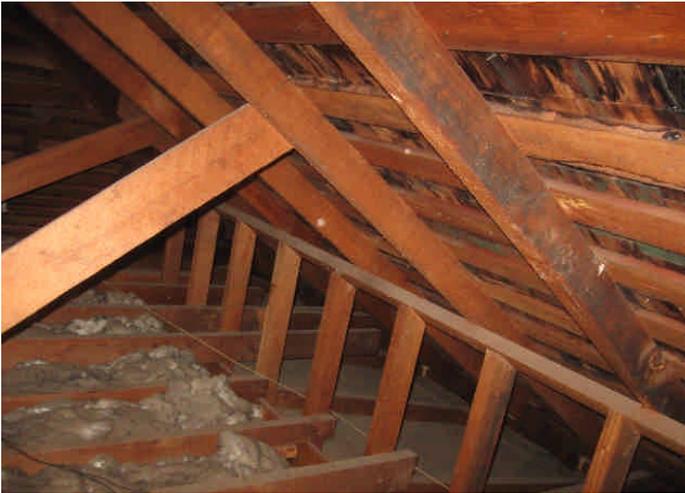
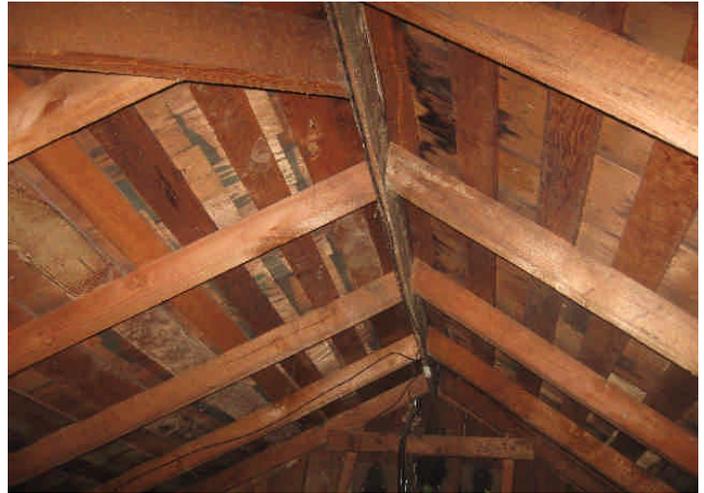
- The visible portions of the framing are in acceptable condition, and would conform to the standards of the year in which they were constructed. Current construction methods would possibly require additional brackets and metal clips to assist in holding the vertical support members in place, however, no supports were found to be displaced during the inspection.

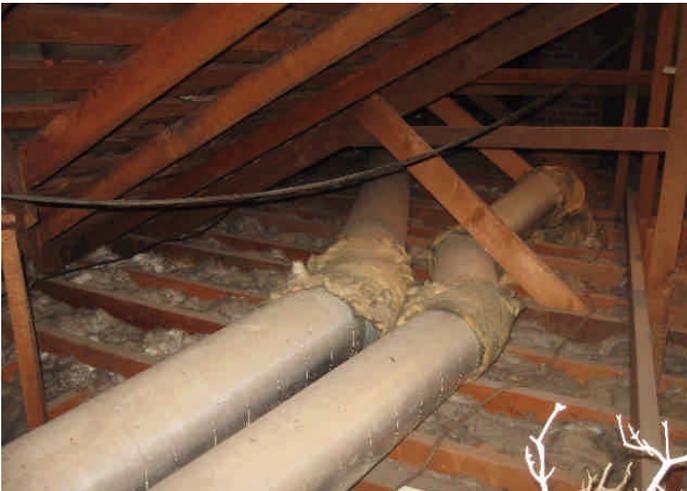
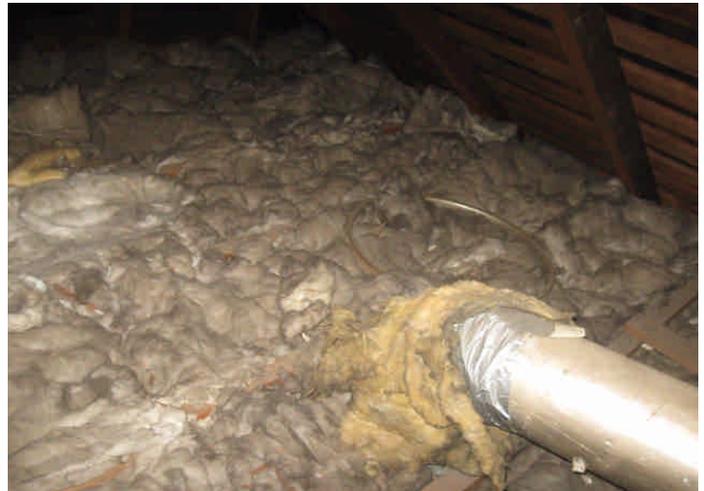
**Heating-Cooling ducts in attic**  
*Informational Conditions*

- The visible heating-cooling ducts in the attic did not appear to have any damage at time of the inspection.

- This age building and heating-cooling system can contain asbestos, asbestos inspection and laboratory testing for asbestos is not part of this inspection, recommend upgrading any asbestos materials to newer approved products with any asbestos properly removed and disposed of.

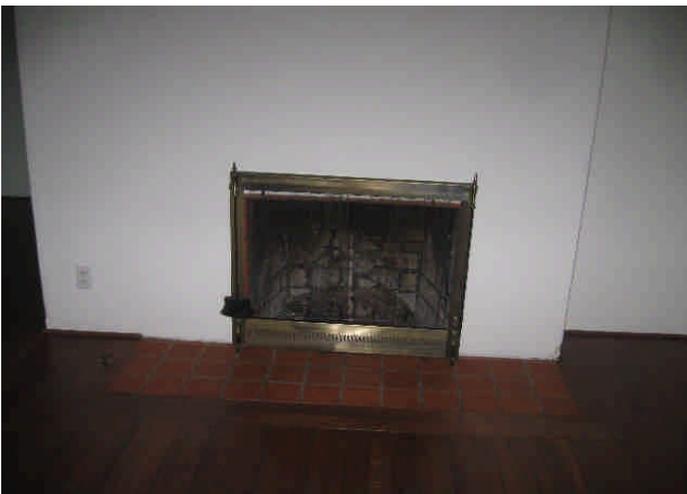
- The fireplace did not appear to have any unusual displacement or damage, clearance to combustibles appeared adequate on visible portions of the fireplace, the hearth was in place.

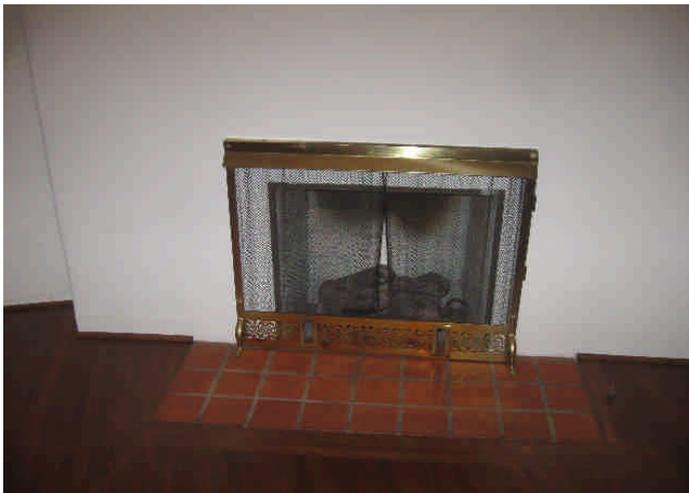
- The fireplace did not appear to have any unusual damage or displacement.

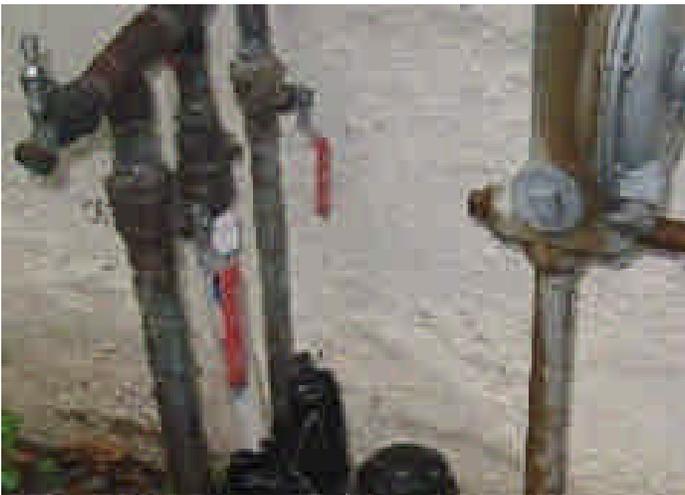
- Water main shut off is a newer style ball valve.
- The main water shut-off valve is located at the front of the building.

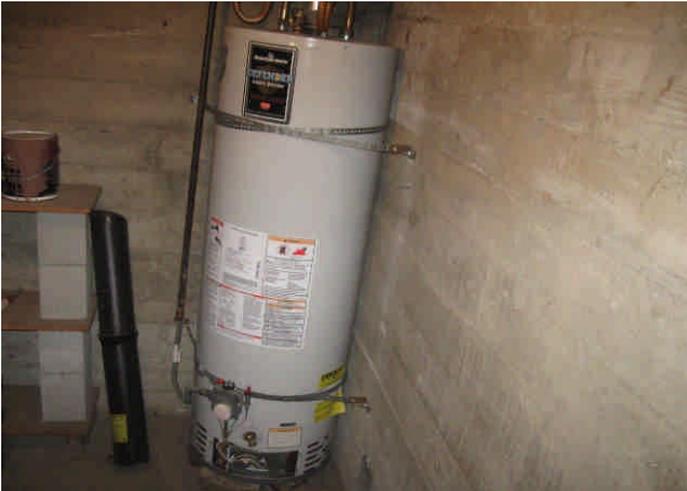
The residence is served by a gas water heater located in the basement - *Continued*

- The water heater was producing hot water at the time of the inspection.
- Hot water is provided by an approximately 4 year old, 50 gallon gas water heater that is located in the basement.

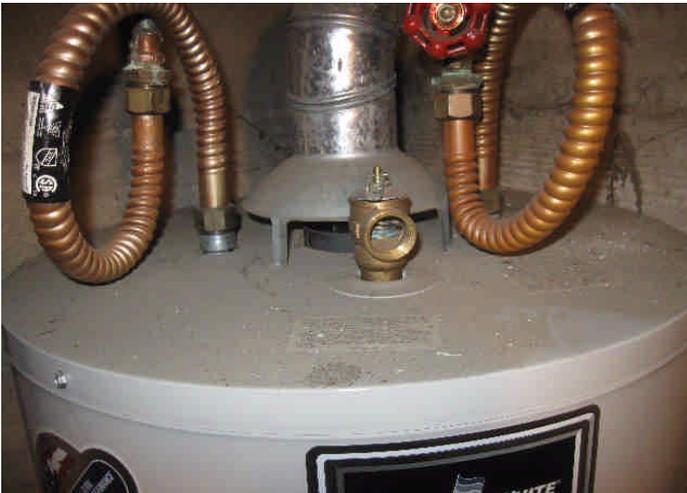
- The water heater is equipped with a mandated pressure-temperature relief valve.

- ✓ The discharge pipe from the pressure relief valve on the water heater is missing and is required be installed with an approved 3/4" smooth wall piping such approved copper, pointed downward and terminate with no more than twenty-four inches above grade and no closer than six inches to it. The termination point is recommended to be at the exterior of the building at a safe location to prevent a possible water spill in the structure. If galvanized pipe is used the termination end threads are required to be cut off so that no one can cap the down spout pipe. If exterior termination on the down spout is not possible, consideration for installing a Watts 210 gas shut off valve is recommended.

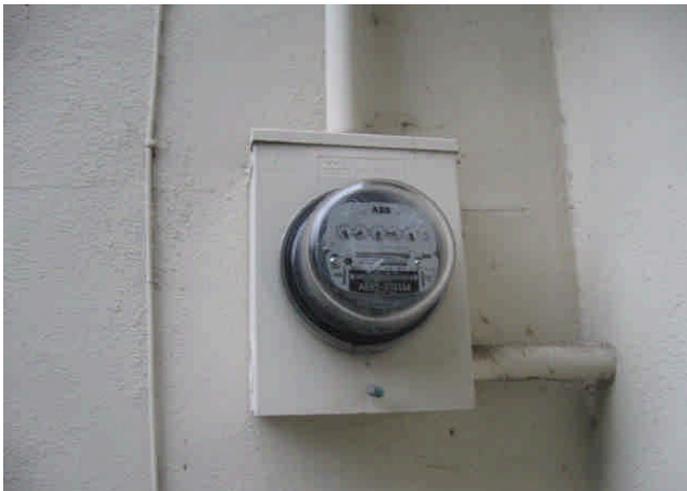
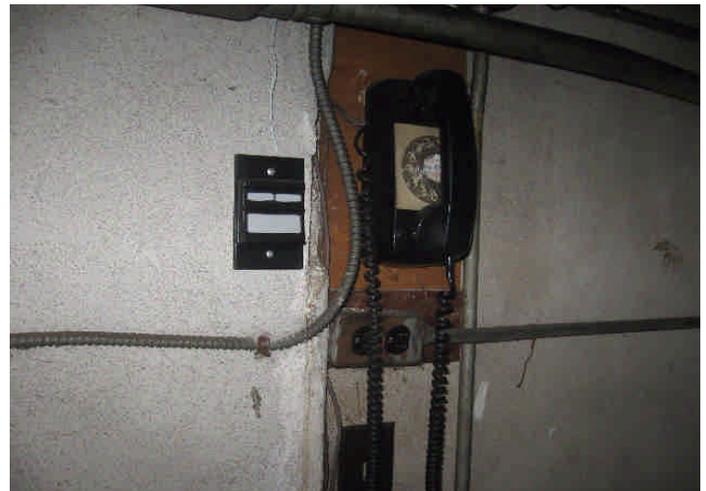
- The residence is served by a 100 amp, 120\240 volt panel, located inside the garage with the meter on the outside of the garage.

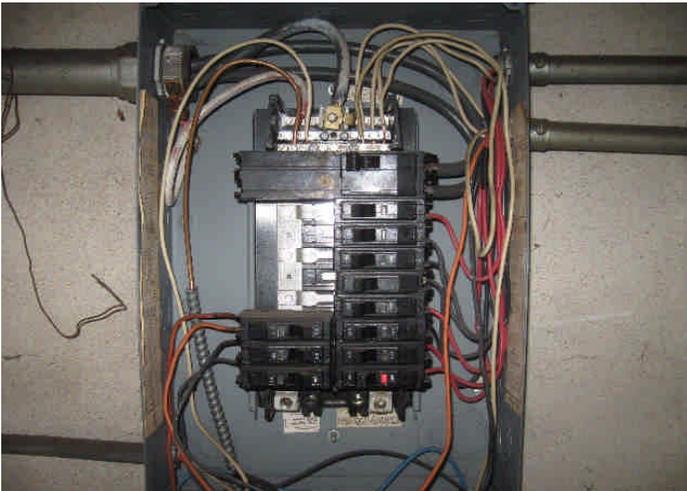
- There is no visible damage to the circuit breakers or wires in the main electrical panel.

- ✓ A breaker in the main panel is serving more than one circuit. This condition should be evaluated by an electrician for installation of an additional breaker.

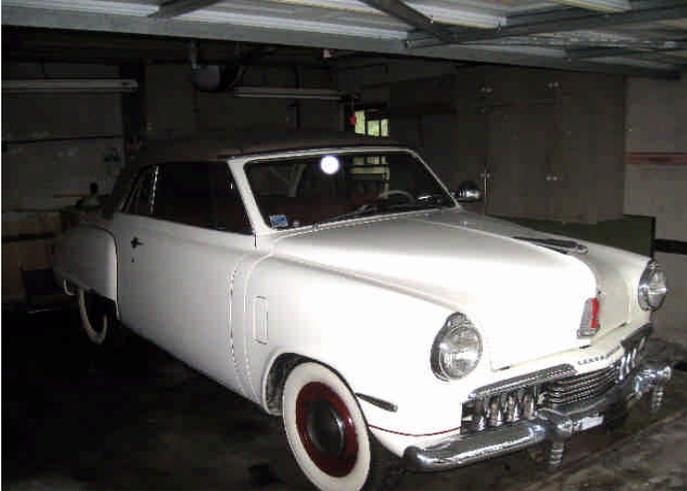
- The visible portion of the garage slab was in acceptable condition. Small cracks are common and result as a consequence of the curing process, seismic activity, common settling, or the presence expansive soils, but do not appear to be structurally threatening. Also, you may notice some salt crystal formations that are activated by moisture penetrating the slab.
- The garage is too full of storage to permit a clear view of all the slab and other components.
