## CONFIDENTIAL INSPECTION REPORT

# 36 Shadow Ranch, La Mesa , CA

11/21/2009 2:00 pm to 5:30 pm

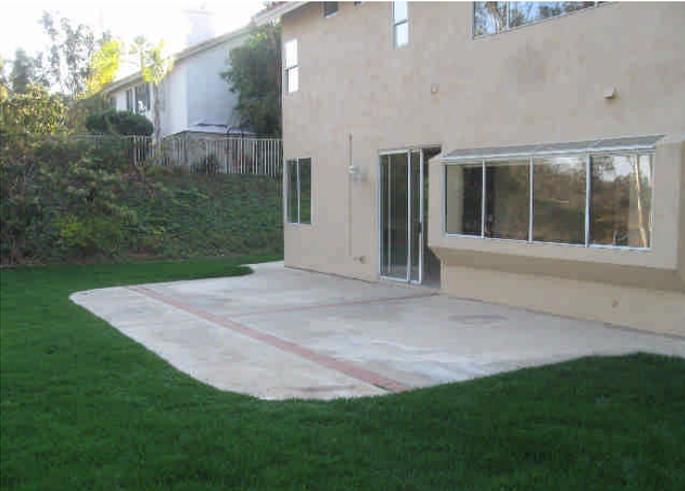
Patio masonry pad does not appear to have any unusual displacement or cracking - *Continued*

- The patio concrete has been improperly installed close or over the stucco weep screed flashing, it does appear to have slope directing water away from the walls and no evidence of moisture intrusion was found at the time of the inspection, however, moisture intrusion will remain a possibility, monitoring for moisture intrusion is recommended and particularly during rainy weather to verify no moisture intrusion is occurring.

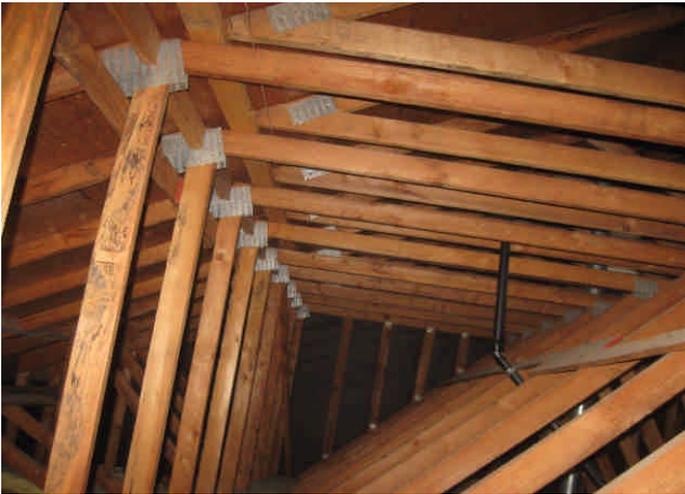
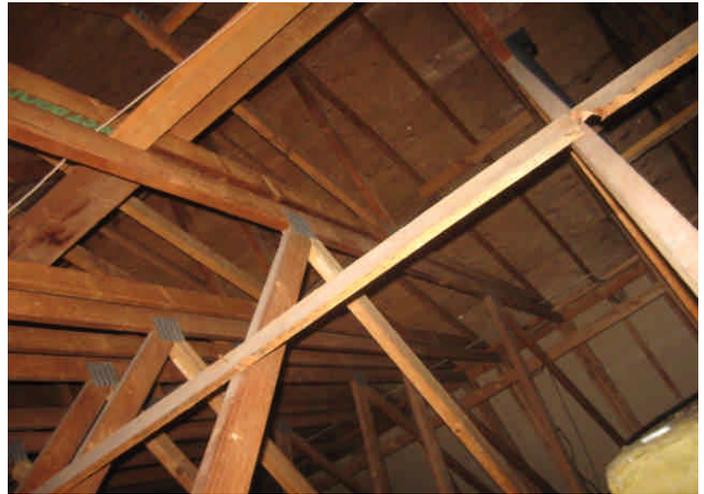
- The roof framing consists of a factory- built truss system, comprised of components called chords, webs, and struts that are connected by wood or metal gussets nailed or glued in place. Each component of the truss is designed for a specific purpose, and cannot be removed or modified without compromising the integrity of the entire strut. The lowest component, which is called the chord and to which the ceiling is attached, can move by thermal expansion and contraction and cause creaking sounds, which are more pronounced in the mornings and evenings along with temperature changes. Such movement has no structural significance, but can result in small cracks or divots in the drywall or plaster. No unusual movement or damage was found on the visible portions of the truss system at time of the inspection.

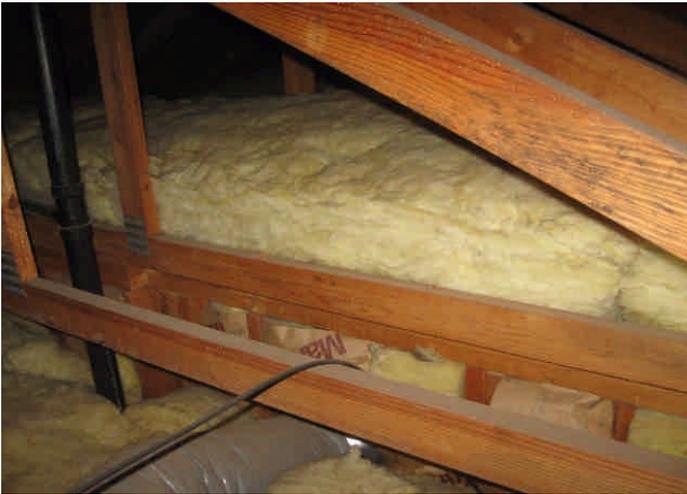
- The attic floor is well insulated with approximately nine-inches of fiberglass, batt insulation.

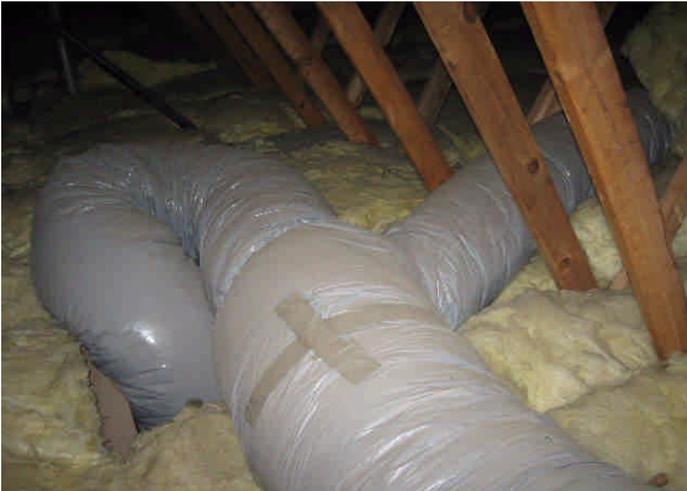
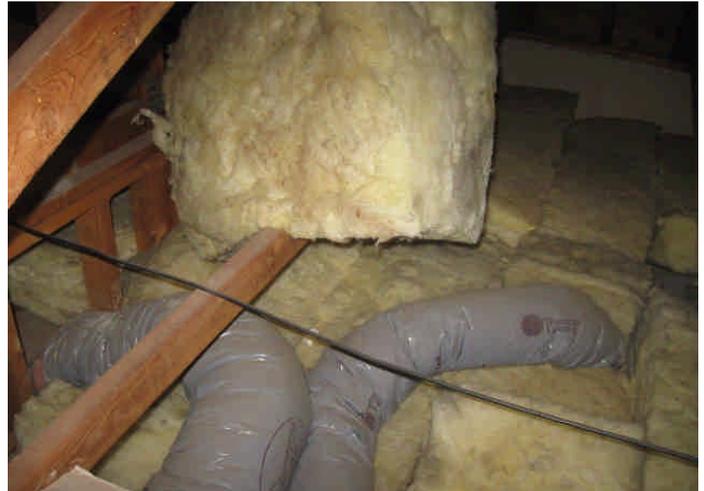
**Heating-Cooling ducts in attic**

The visible heating-cooling ducts in attic did not appear to have any damage at time of the inspection - *Continued*

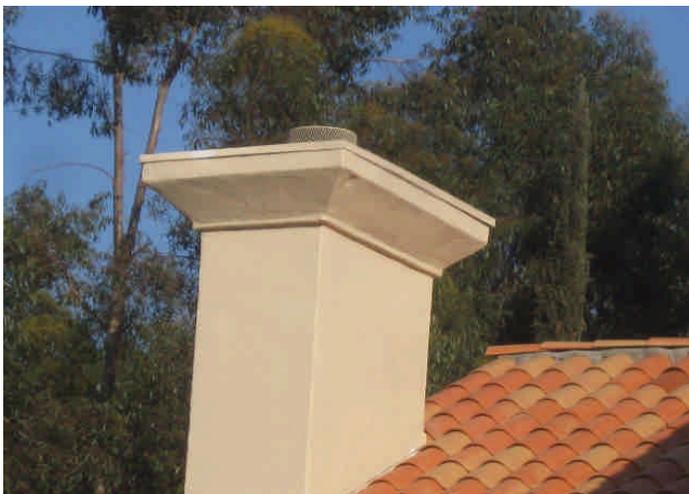
- A spark arrestor housing is in place on the chimney.

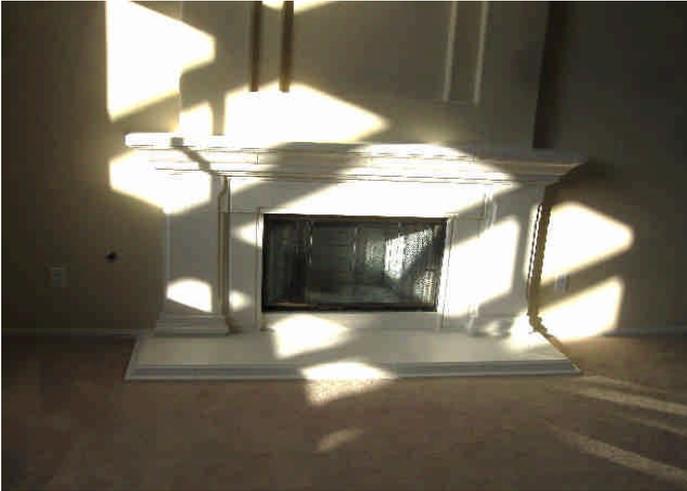
- The fireplace did not appear to have any unusual displacement or damage, clearance to combustibles appeared adequate on visible portions of the fireplace, the hearth was in place.

- Gas pipe is installed into the fireplace with a wall valve outside the fireplace, however, gas pipe was capped at the fireplace, but was obviously not tested.

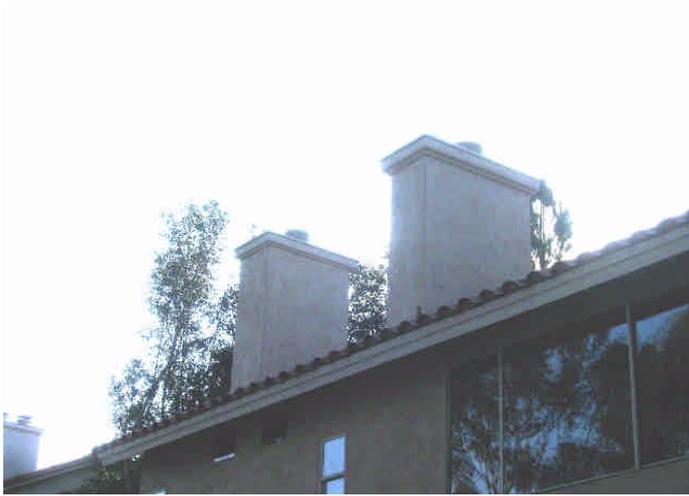
A functional spark arrestor is in place on the chimney - *Continued*

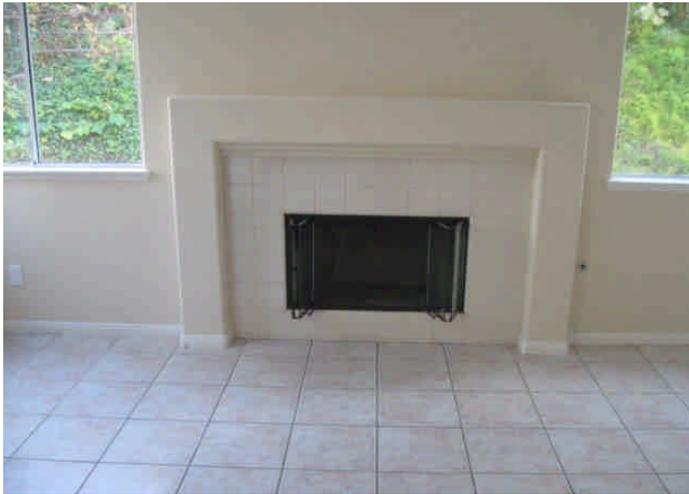
- The fireplace did not appear to have any unusual cracking or damage, the clearance to combustibles appeared to be appropriate.

- Gas is in and capped at the fireplace, but was obviously not tested.

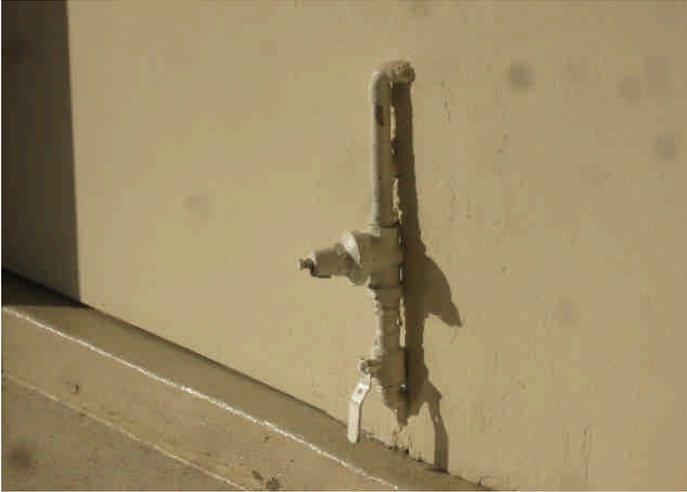
The main water shut-off valve is located inside the garage - *Continued*

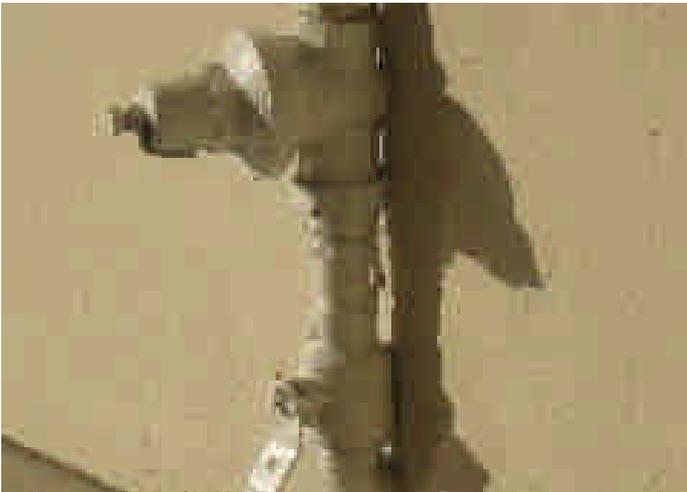
- An adjustable water pressure regulator is in place on the plumbing system. Pressure regulators can normally be adjusted by turning the bolt clockwise for increasing the pressure and counter clockwise for decreasing the pressure, recommend not adjusting the pressure over 80 psi.

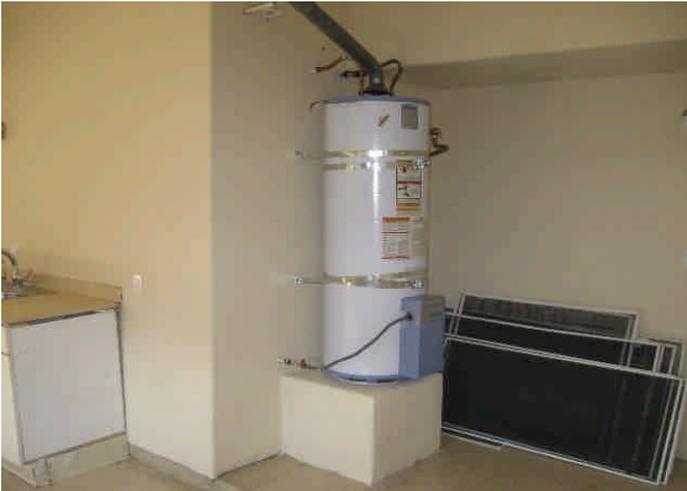
The property is served by a gas water heater located in the garage - *Continued*

- The hot water heater was not producing hot water at the time of the inspection and should be serviced. Recommend having the Gas Company light the pilot and verify that the water heater will heat water properly. Recommend all the faucets at sinks, tubs\showers are verified as producing hot water before the close of escrow.

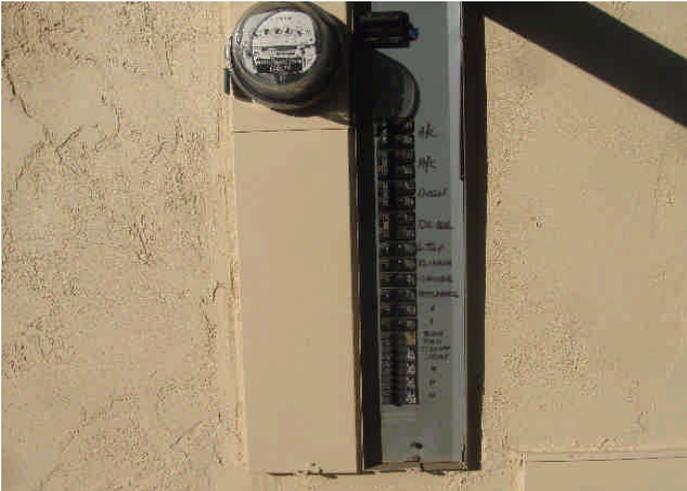
The interior cover for the main electrical panel is in acceptable condition - *Continued*

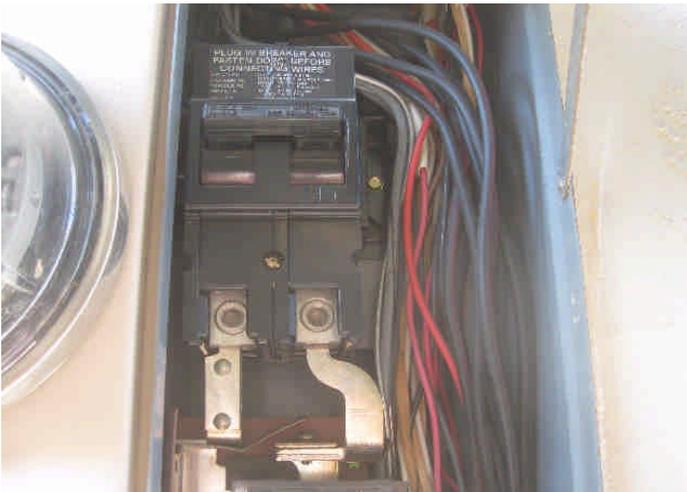
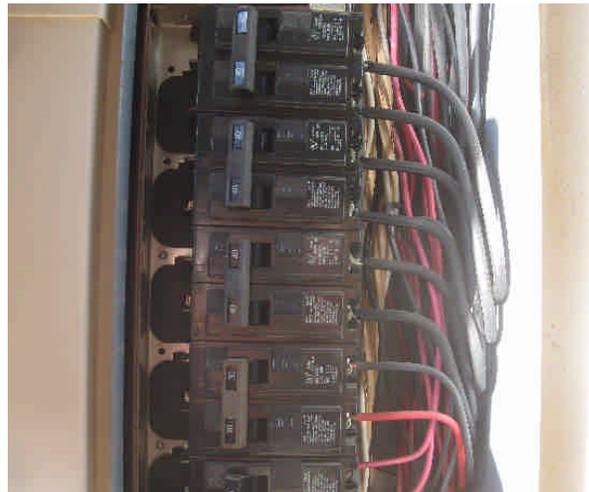
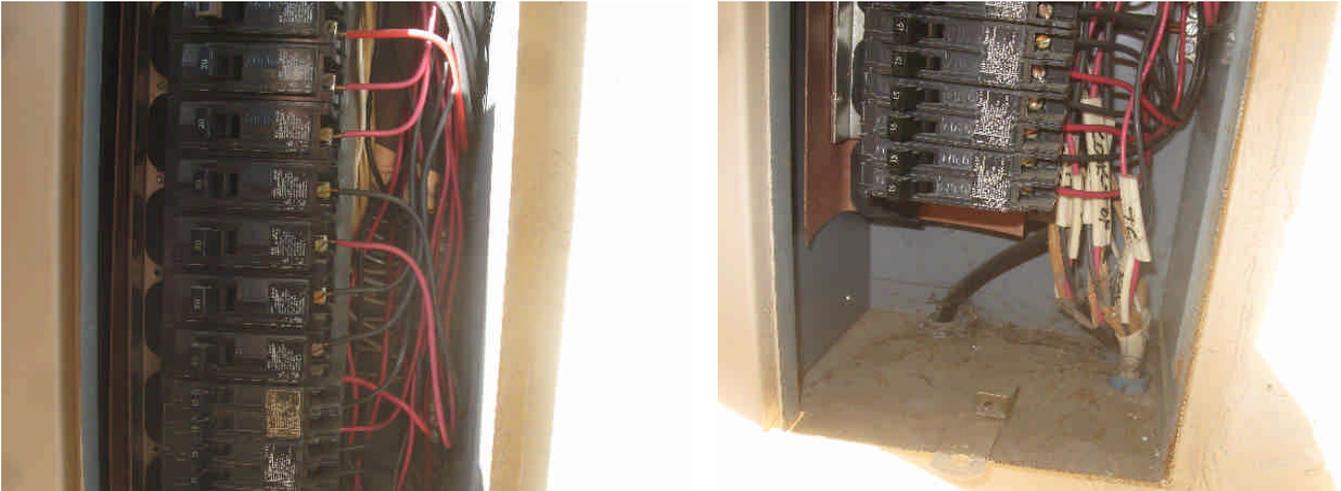
- There is no visible damage to the circuit breakers or wires in the main electrical panel.

There is no visible damage with the circuit breakers in the main electrical panel - *Continued*

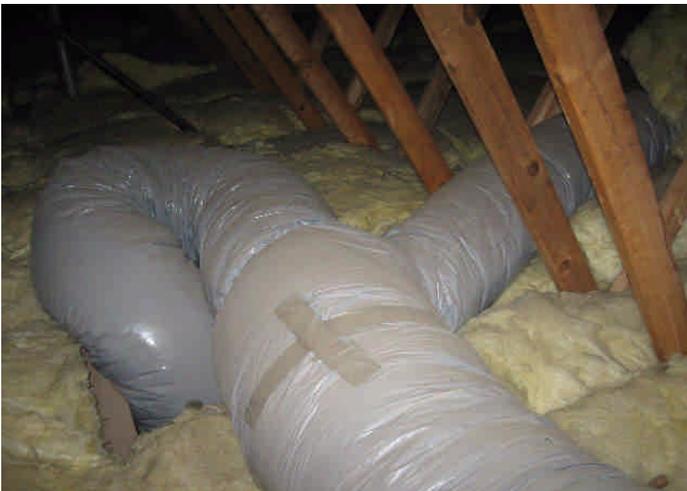
- The visible supply ducts are a modern, flexible type, comprised of a dark-gray, foil or black, plastic, outer sleeve and a clear inner liner that encapsulates fiberglass insulation, and did not have any visible damage.
